DI-764:

Performed and tested by Clint.

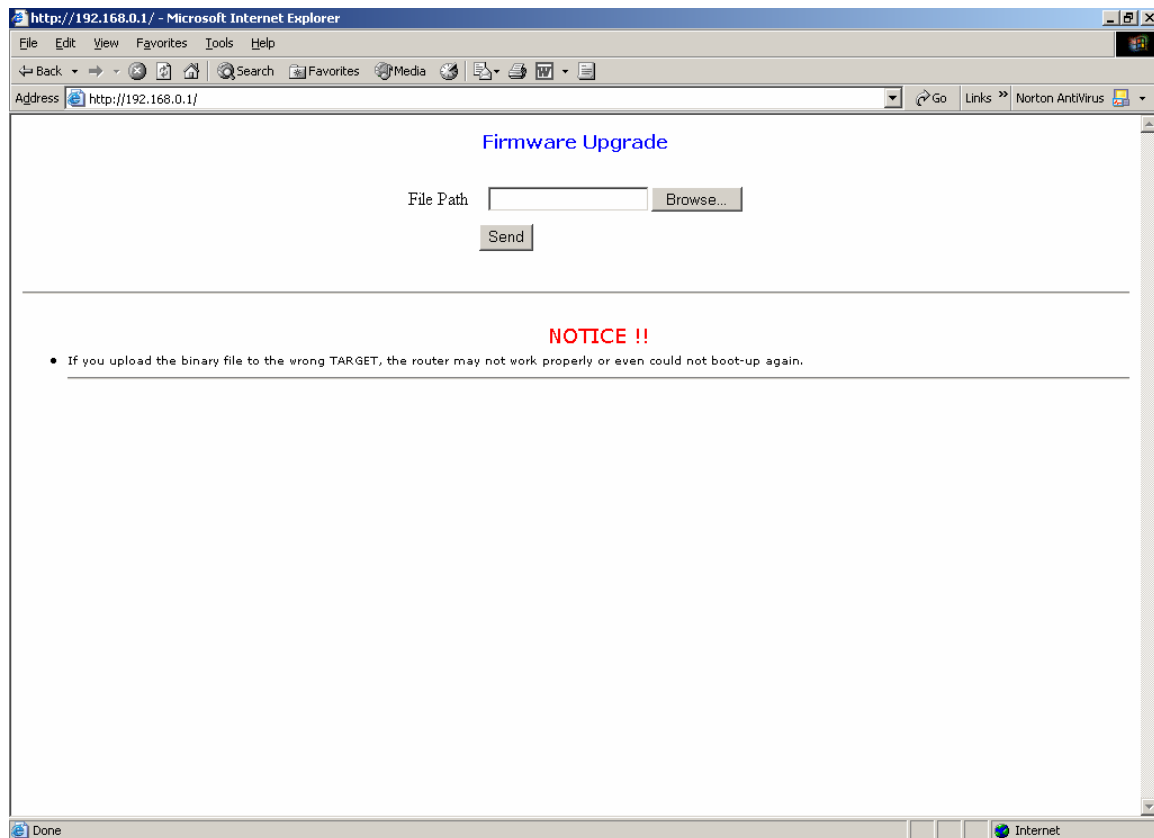
1. The M2 led is constantly on, and unable to ping unit. (No response).
2. By holding in the reset button and turning the power off, then powering the unit back on and waiting for 5 seconds, the M1 led will come active and the M2 led will start to flash.

You are now able to ping the device. And the screenshot is below:

It explains to me to reload the Firmware.

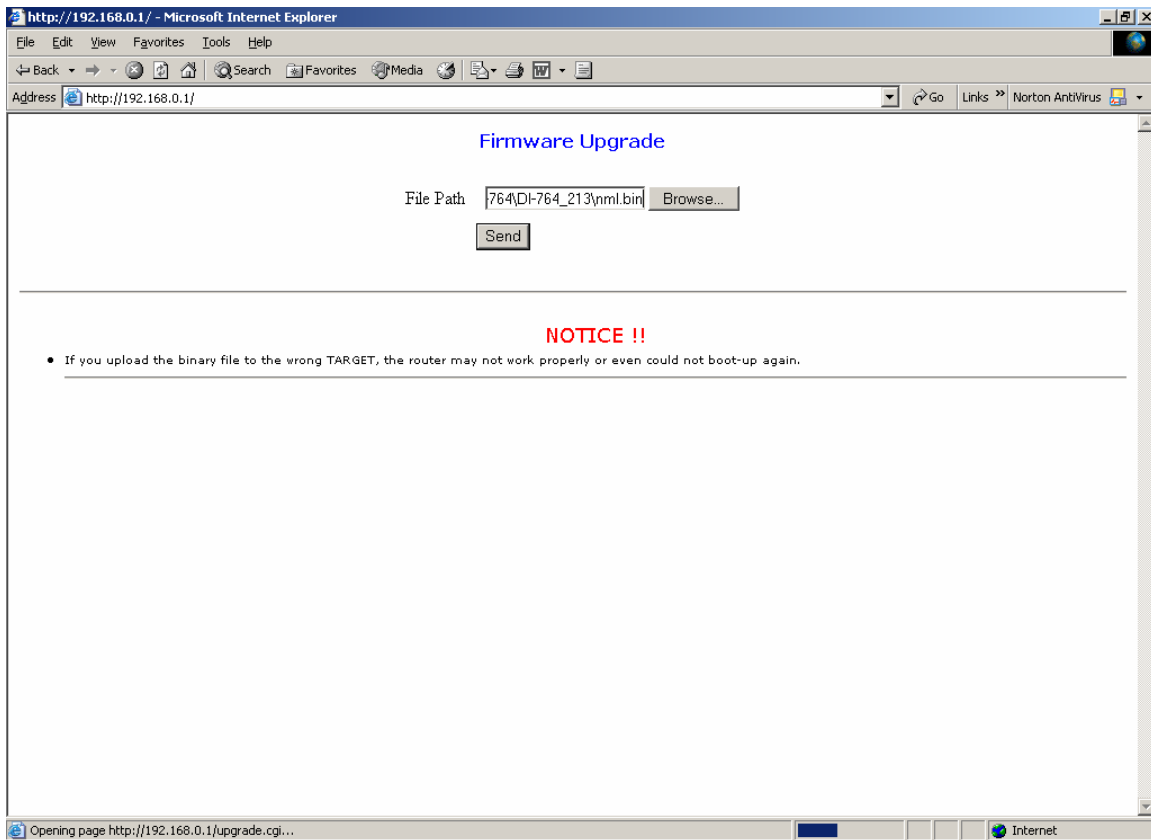
5. The unit stops about half way of the upgrade procedure, and no indication of it being sent or uploaded successfully into unit. Though the progress bar will not move any further.

3. Browse to the .bin file firmware. Which was v1.02.

4. Then press the Send button and wait.

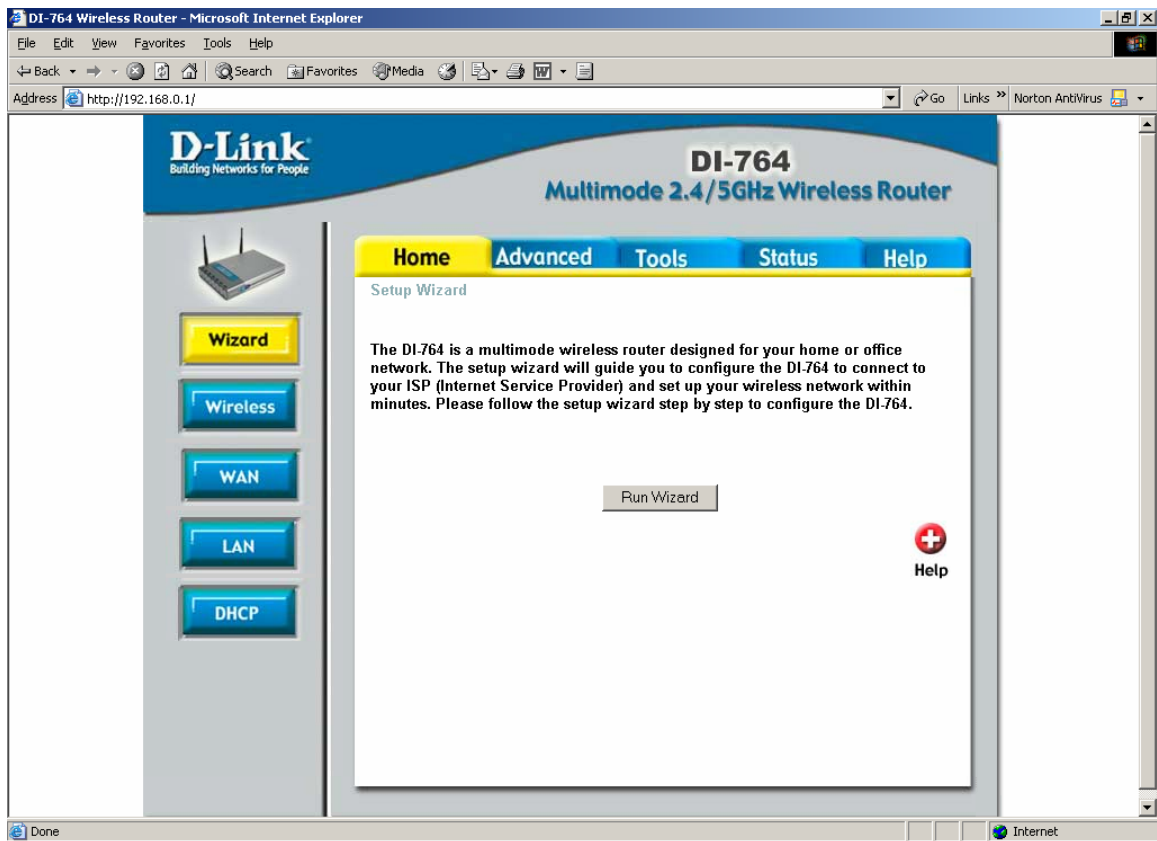
7. You should now see the M2 led will light up and then M1 led will light up and the M2 led will not be on.

8. You can now ping the device and access it as well.

6. Press and hold the reset button, and remove the power to the unit, then power the unit, give it 5 seconds and release the reset button.

9. You can then proceed to update the firmware to the current of this write up which is v2.13
