**Firmware Version:** V1.20.B040  
**Boot Code Version:** 1.00.007  
**MIB Version:** V1.20.B026  
**Published:** Oct. 11, 2024

These release notes include important information about D-Link switch firmware revisions. Please verify that these release notes are correct for your switch:

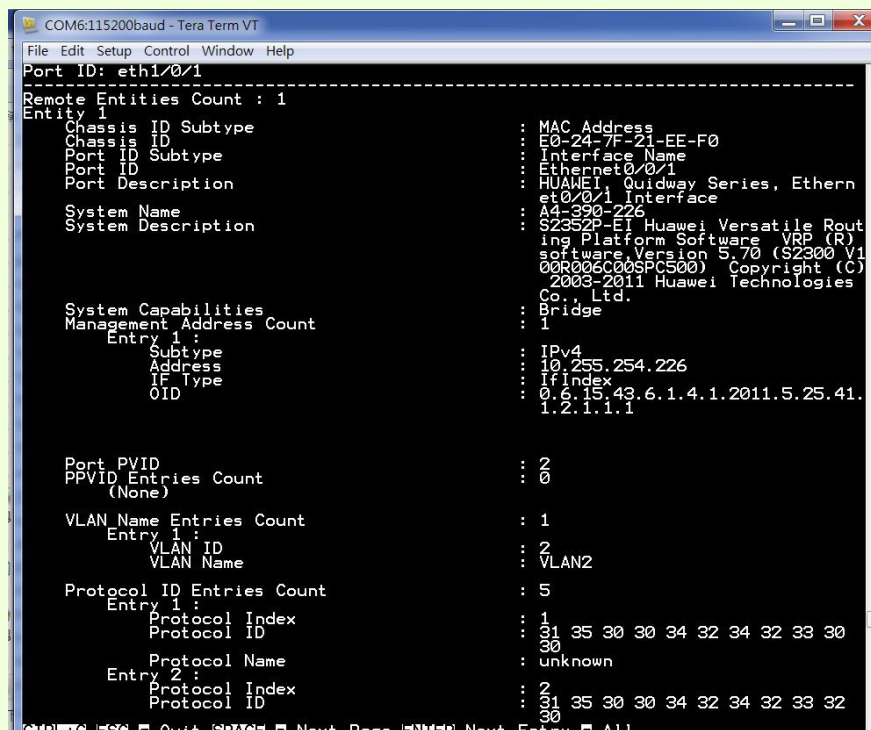
## 5. VBG17060155

Show lldp neighbors interface Ethernet 1/0/1 detail information incomplete.

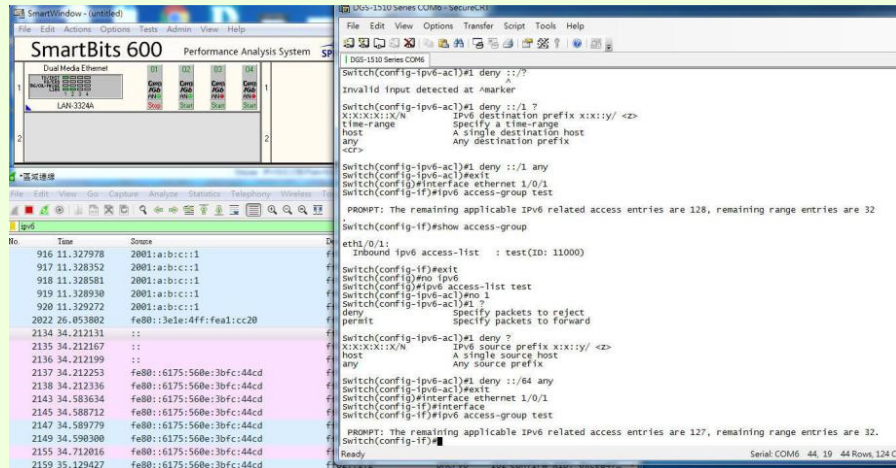
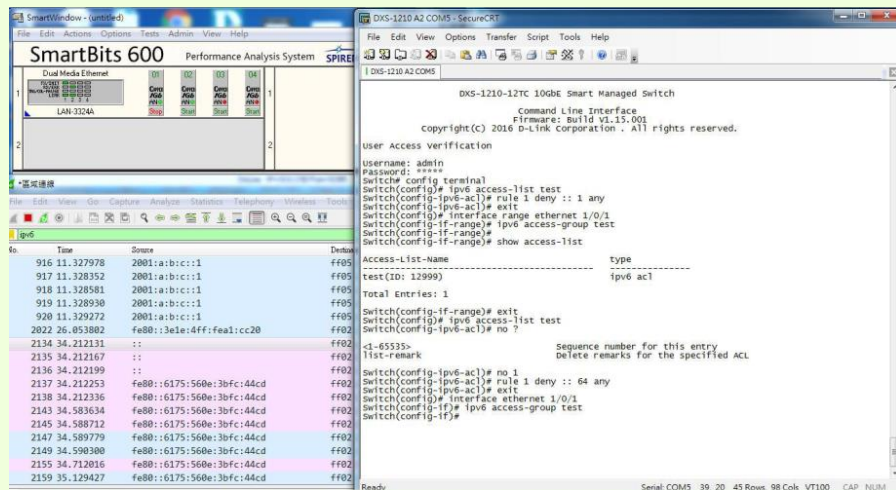
## 7.VBG17050038

DXS-1210 Rev.A2 FW 1.15.001 test result fails. Follow D-Link G2 Spec IPv6 perfix (mask) 1-128 does not support 0 (::) settings, we use perfix 64 to test source IPv6 :: deny rule. Test Result source IPv6 :: cannot be deny by ACL correctly.

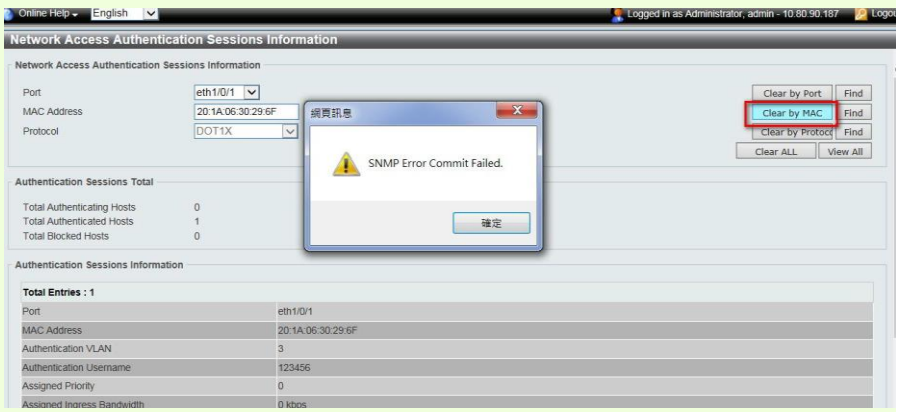
## 8. VBG17080089

Network Access Authentication Sessions Information--> clear by MAC will popup snmp error.

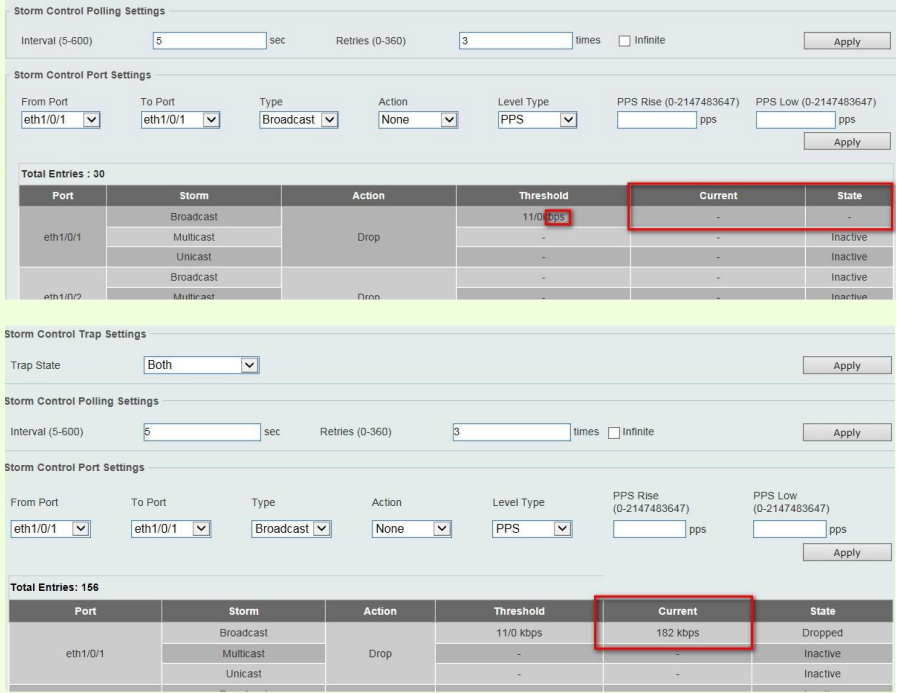
## 9. VBG17080090

Storm Control when Level Type for kbps cannot show current and state.(Limitation)

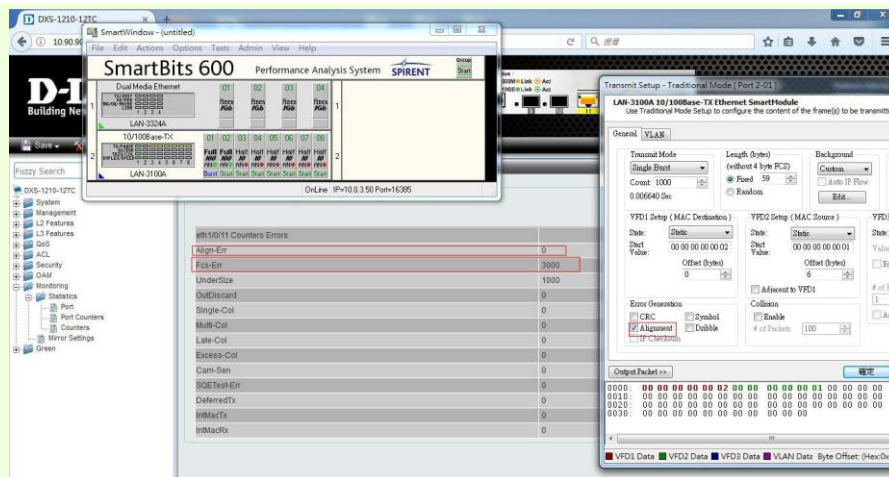
## 10 VBG17060160

The DUT statistics error packets type Alignment error will count to CRC error.

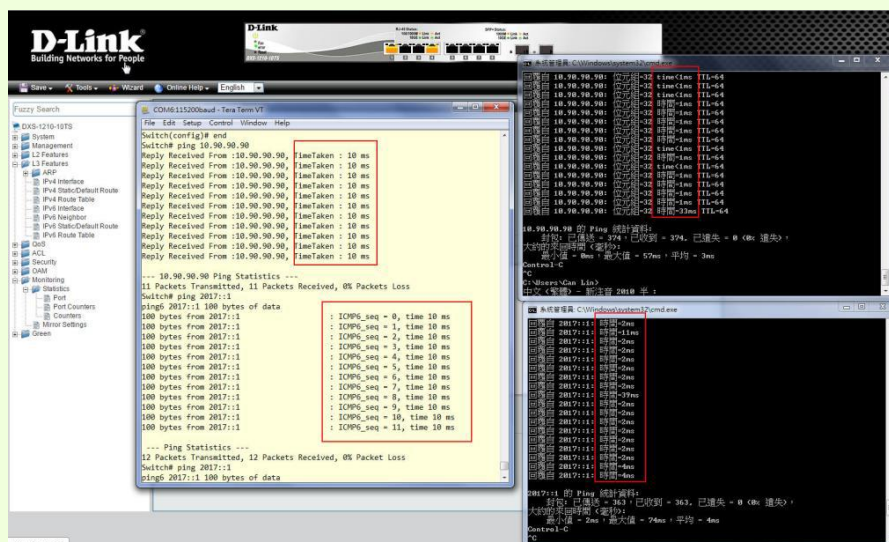
## 11. VBG17060158

The DUT IPv6 ping respond time does not same as IPv4 ping respond time. But use console to ping v4/v6 respond time does same.

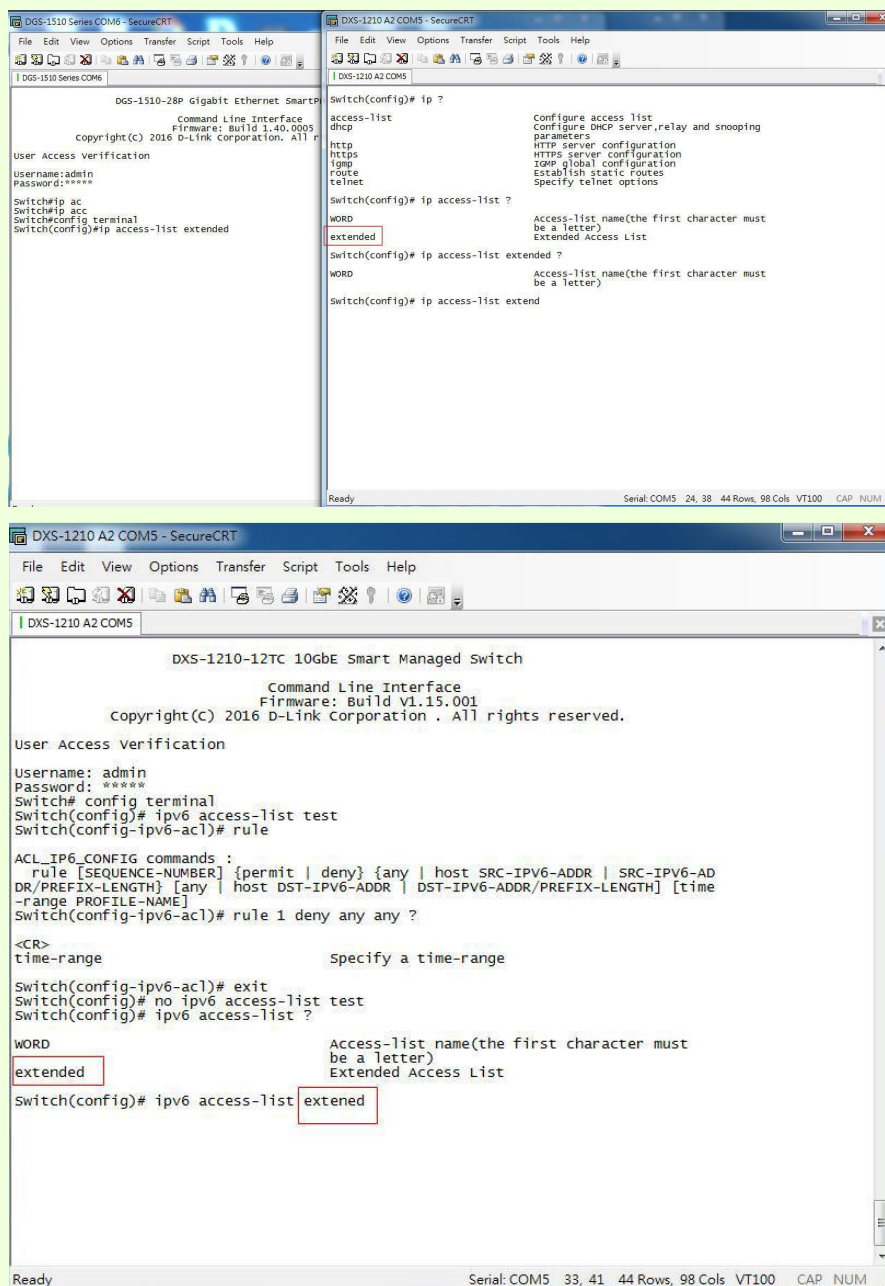
## 12. VBG17060159

The DUT command "ip access-list extended" does not support <tab> help button that does not fit D-Link request.
