**Firmware Version:** 4.10.B022  
**Boot Code Version:** 1.00.017  
**MIB Version:** 4.10.B003  
**D-View Module Version:** 4.0.0.5  
**Published:** Sep. 23, 2016

These release notes include important information about D-Link switch firmware revisions. Please verify that these release notes are correct for your switch:

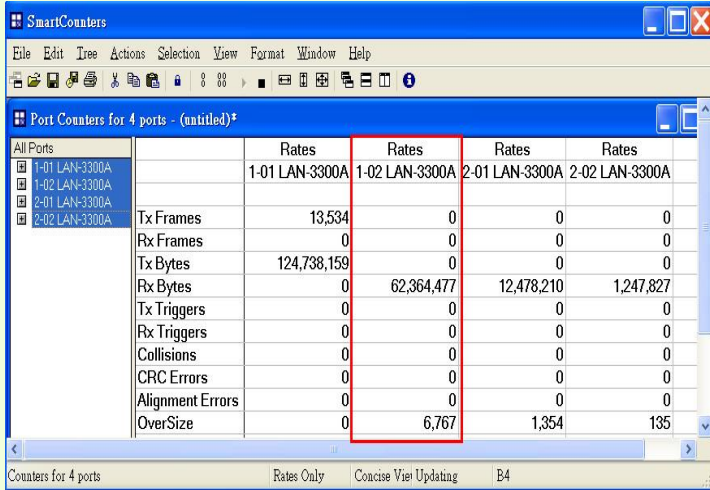
Firmware Version	Issues	Workaround
V4.00.055	<p>1. The DUT exist Head of Line blocking issue via Jumbo Frame packets. (Limitation)</p>

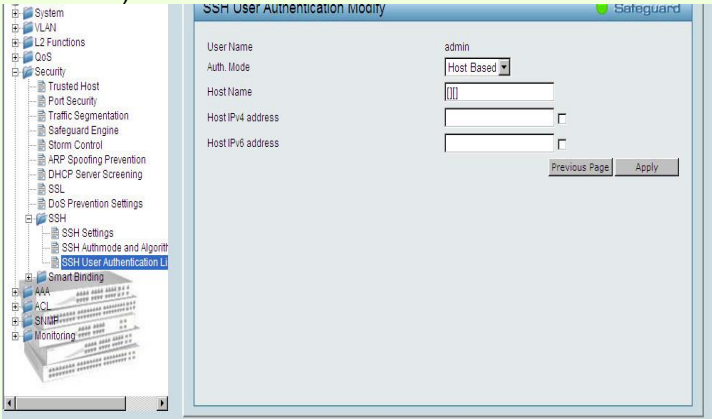
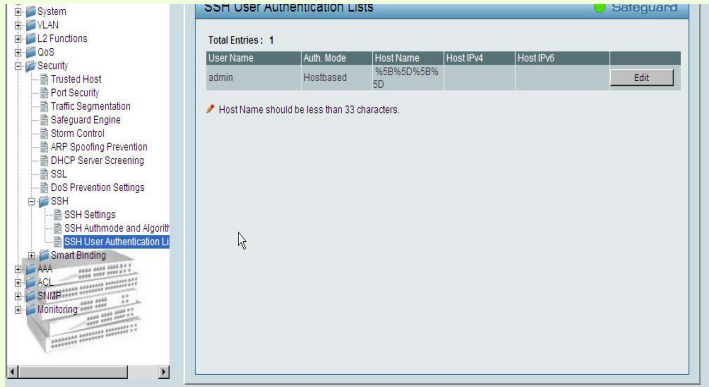
<p>2. When the input invaild characters in the SSH User Authentication appear unusual characters. (Known Issue)</p>

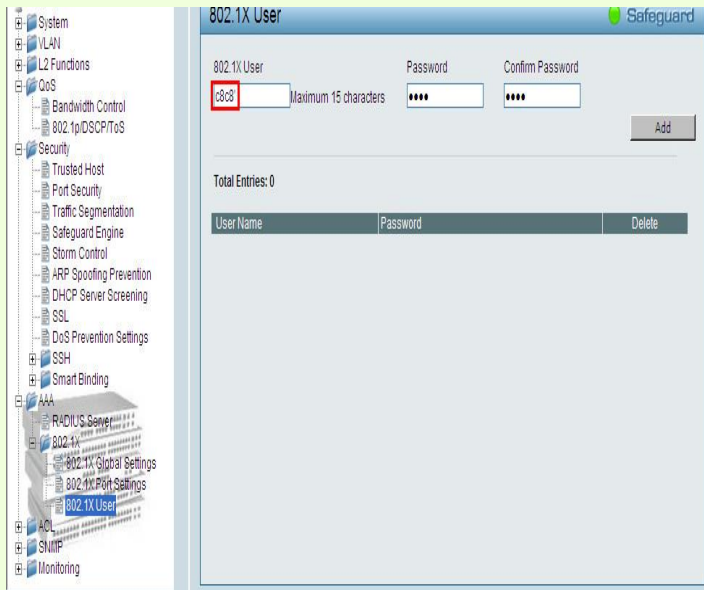
<p>3. When we setting invaild value, has not warning message. Then can't add second account. (Known Issue)</p>	None

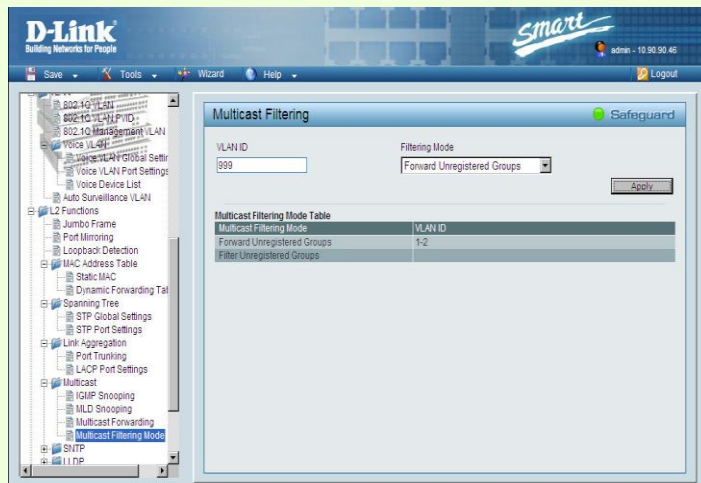
4. When set not exist VLAN ID ,system doesn't display error message. (Known Issue)

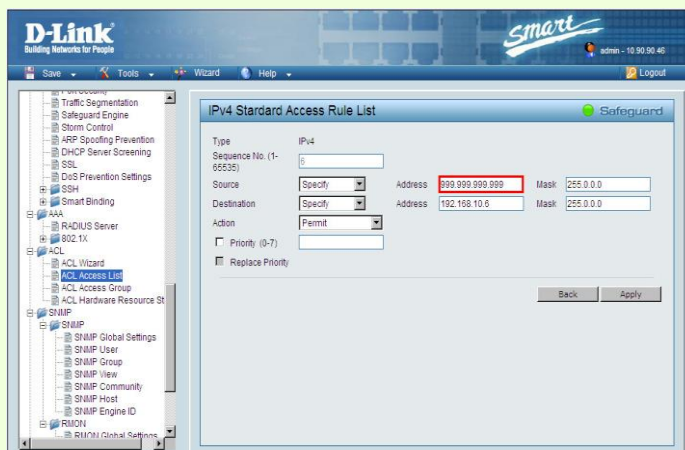
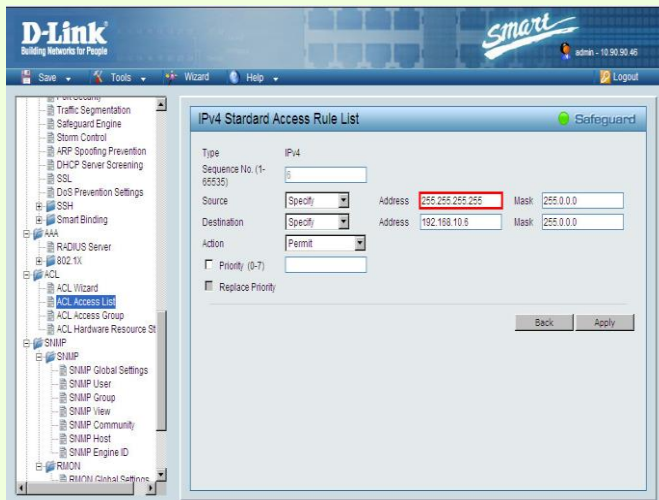
5. The ACL IP not incorrect ,but not pop-up error message. (Known Issue)

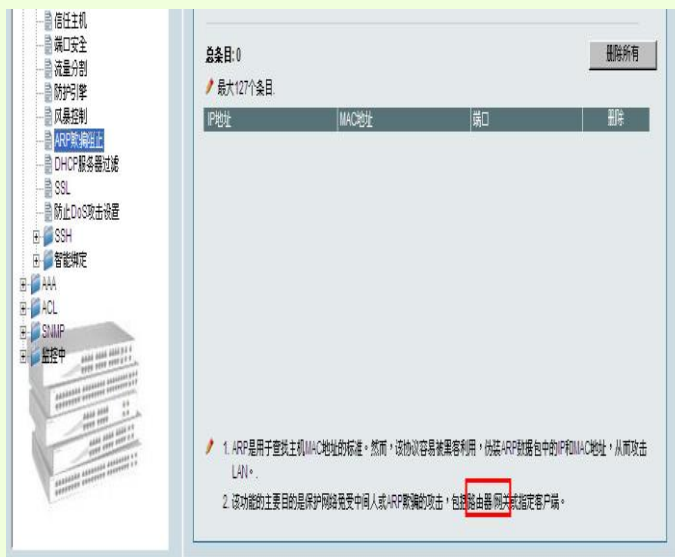
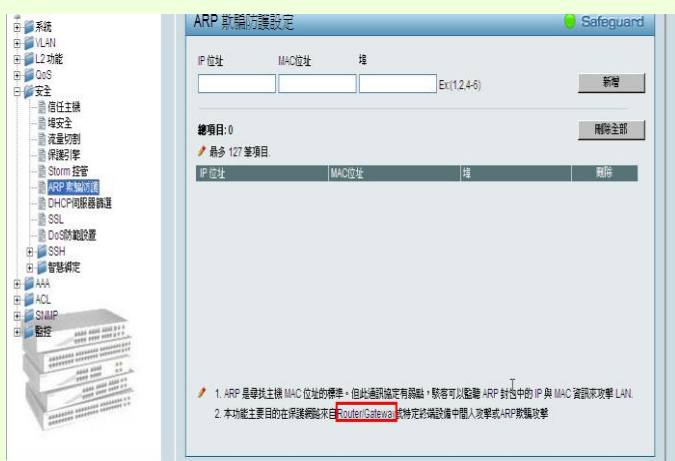
6. SNTP server can not setting ipv4 10.255.0.255. (Known Issue)
7. Traditional Chinese and Simplified Chinese translation description is different on ARP Spoofing Prevention Setting. (Known Issue)

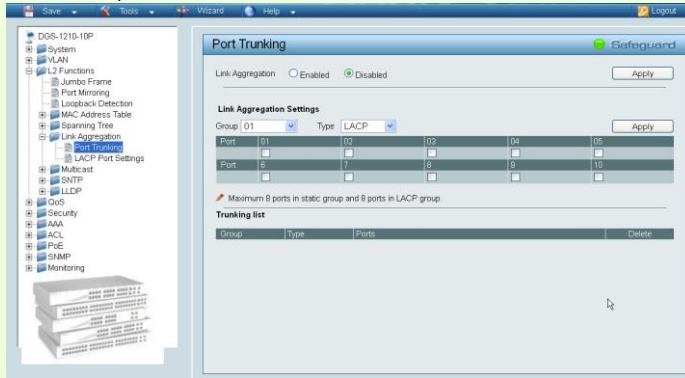
8. Port Trunking page Port number is not identical. (Known Issue)

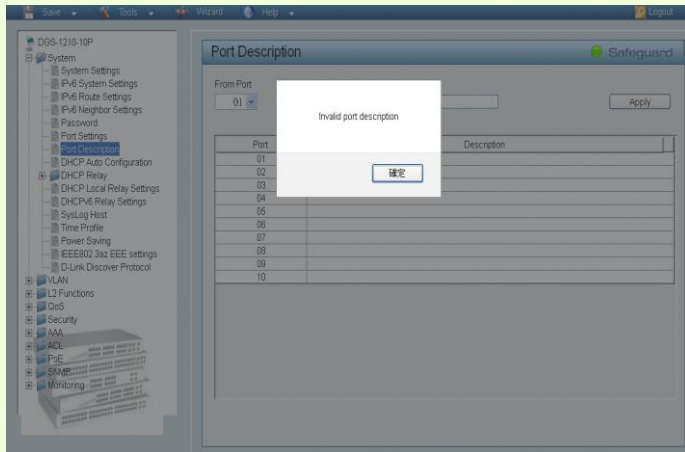
9. Port Description can't set ~!@#\$%^&\*()\_+{}[]=- to the table. (Known Issue)

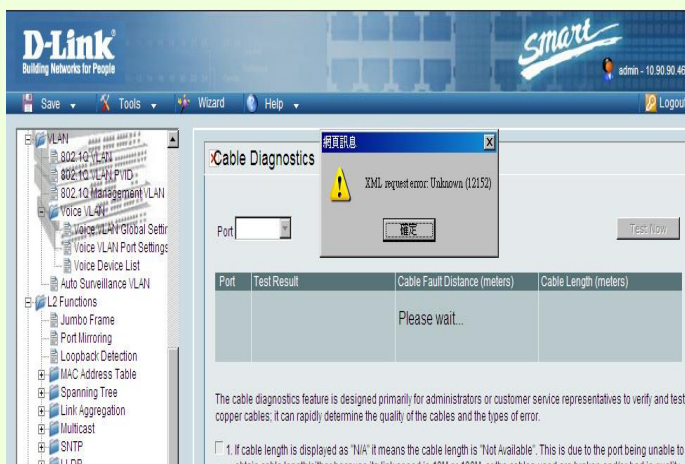
10. When test control PC port to DUT it will pop-up error message. (Known Issue)

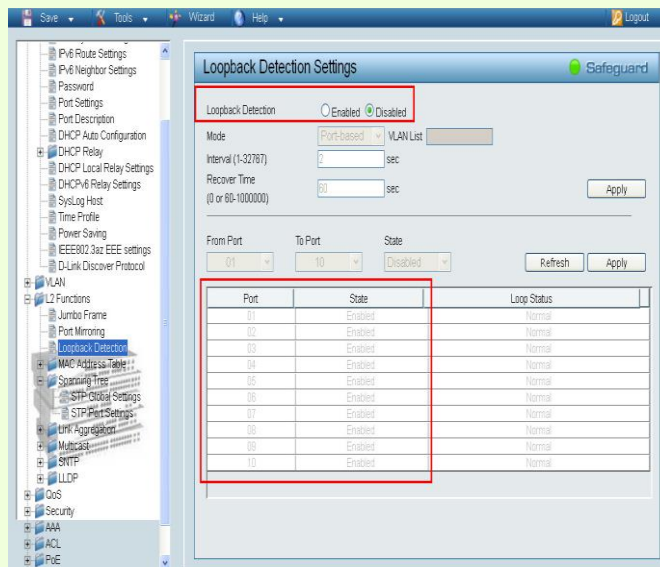
11. When Loopback Detection Global setting disable but per port enable, LACP does can not enable.. (Known Issue)

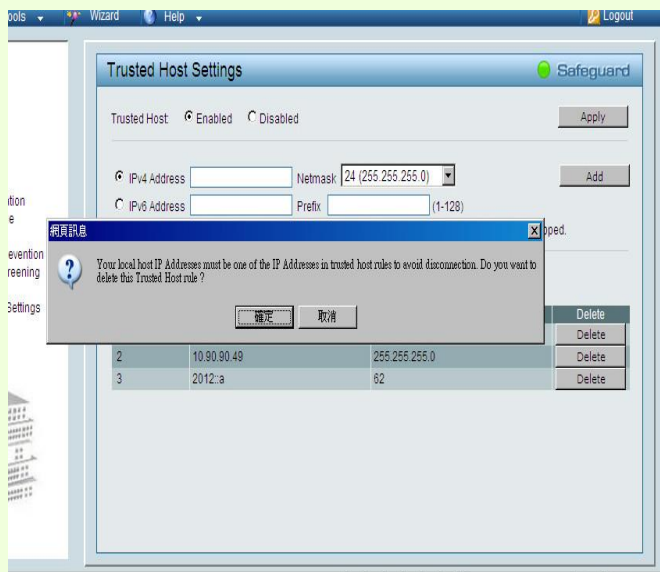
13. When delete IPv6 trust host, the DUT does not pop-up warning message, but IPv4 trust host support it. (Known Issue)
