# DFL-M510 Firmware Release Note

**Firmware: 1.23.00**

**Date: Jun 21, 2006**

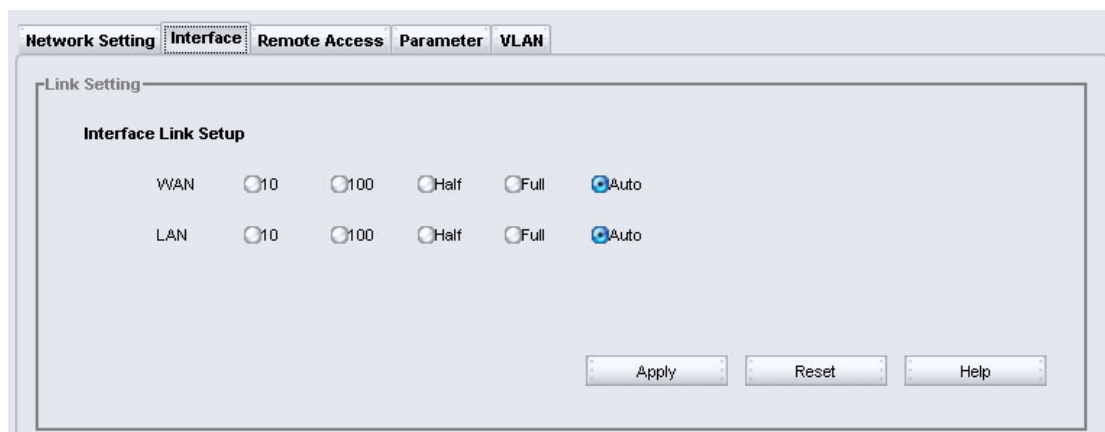
1. When user changes the link status configuration, the function can't work. For example the default setting is “**Auto**”, and we connect to 10/100Mbps switch. The link speed is 100Mbps. When we change to 10 Mbps, the connection speed still is 100Mbps. Please see the Fig.1

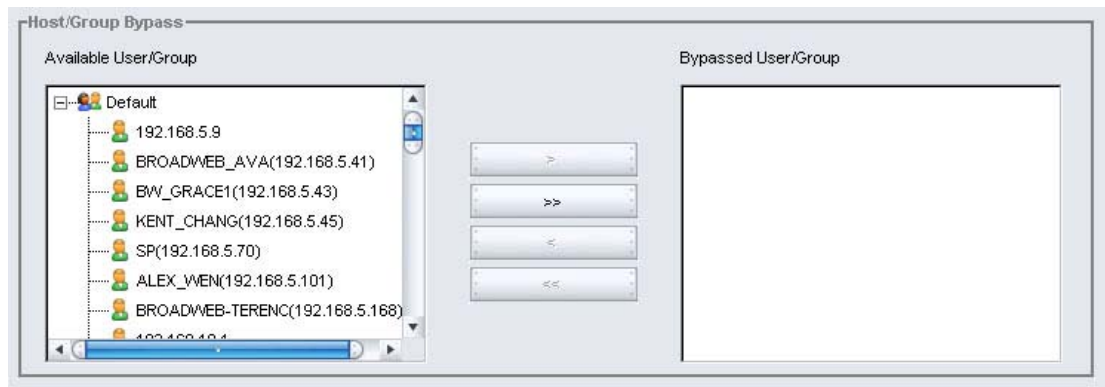
Fig.2

3. Web download can't block \*.rpm file
4. When user try to delete template will find the dialog box can't close.
5. When client use HTTPS to connect to web site, the "Real Time Application" can't display.
6. DFL-M510 will block some packet which from the PCs in Host bypass list.

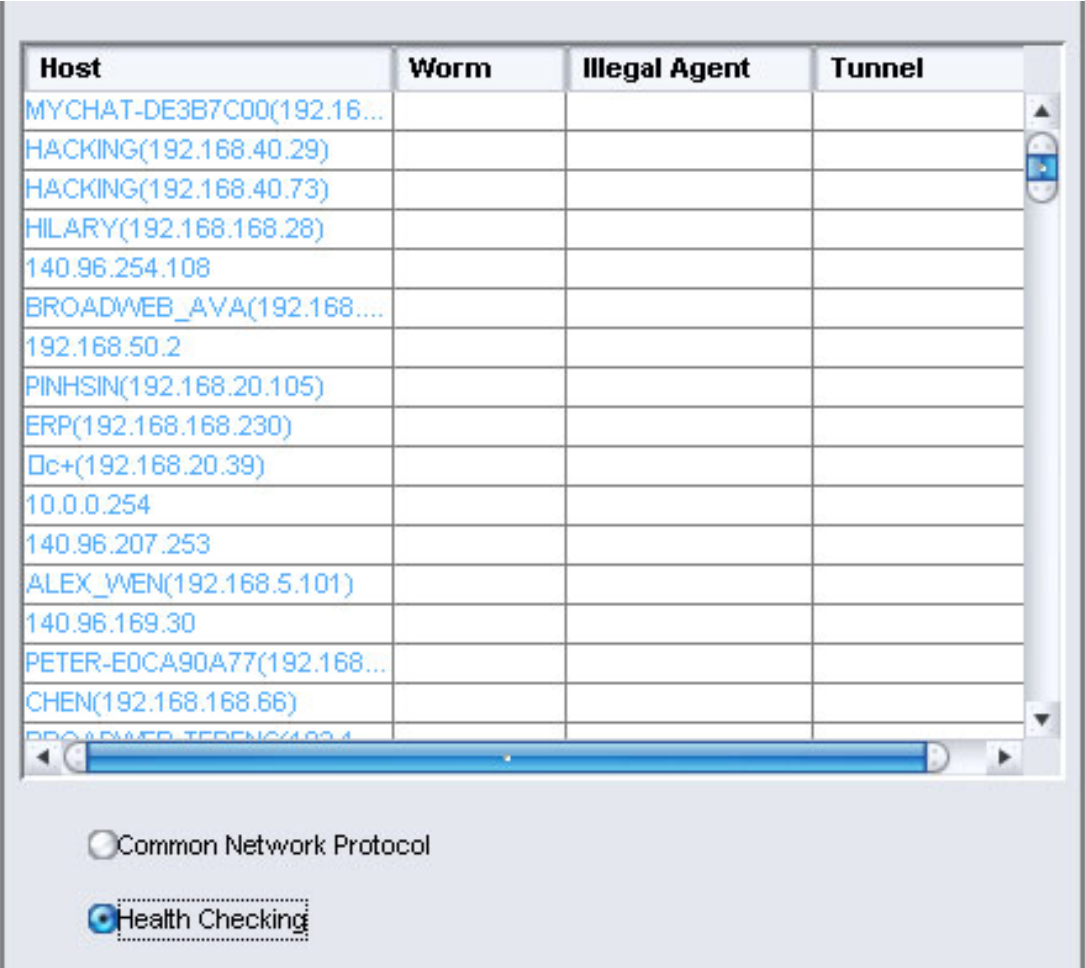
Fig.4

8. When DFL-M510 detects Illegal Agent, “Real Time Application” can’t display.

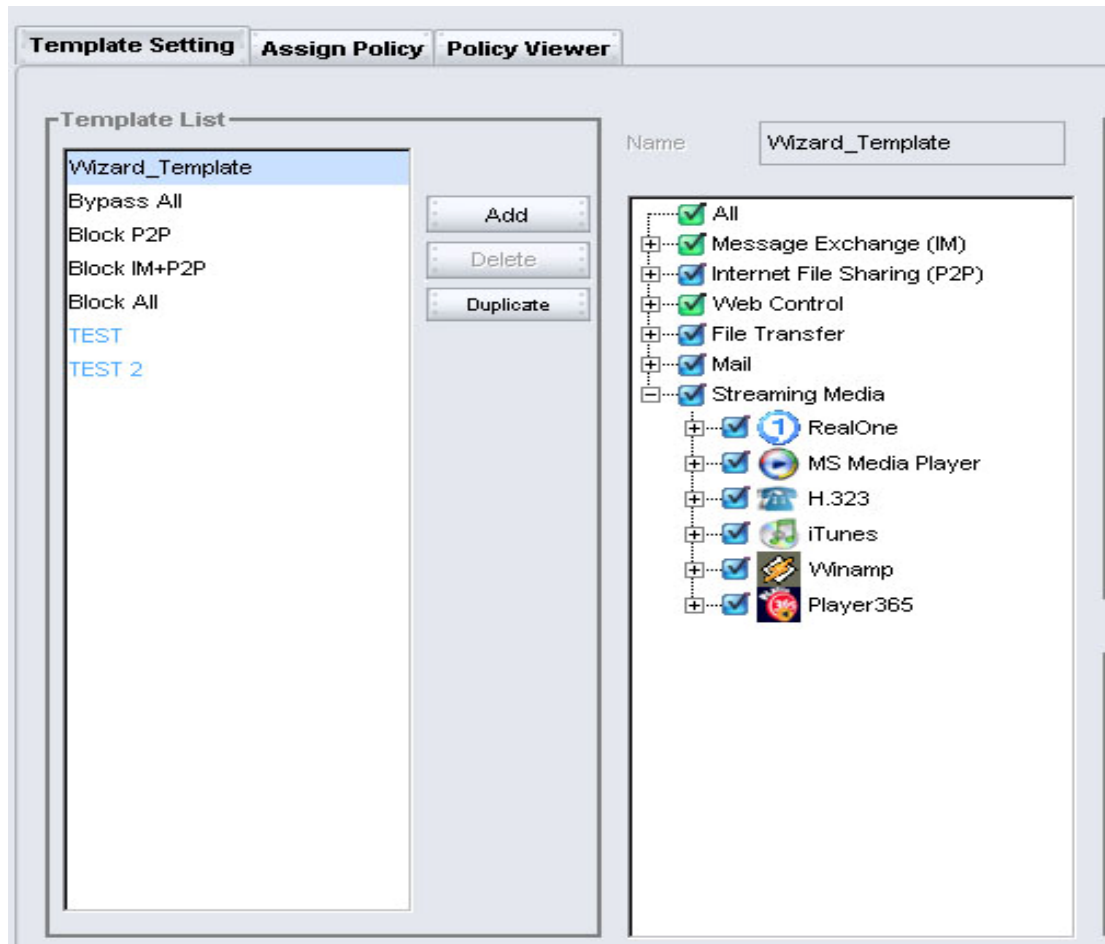
Fig.5

9. Because ASF and WAV file can be open by RealOne, MS Media player ...etc. If we block the Realone, MS Media player, it also block ASF and WAV file.

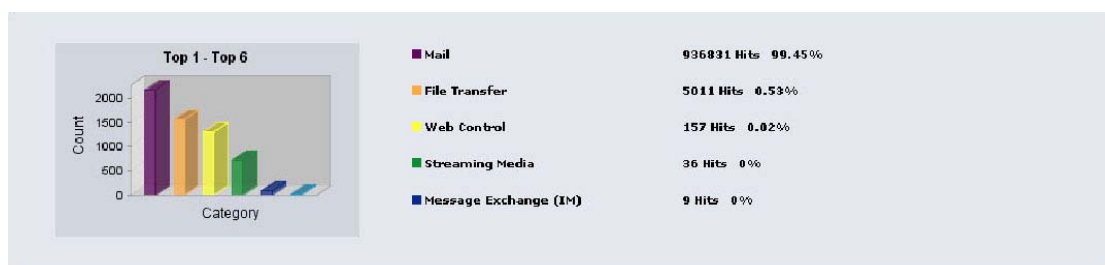
Fig.6

10. Report Bug: Please see the Fig.6. There are five categories, but there are six categories in the chart. The new firmware will fix it, please see the Fig.7.

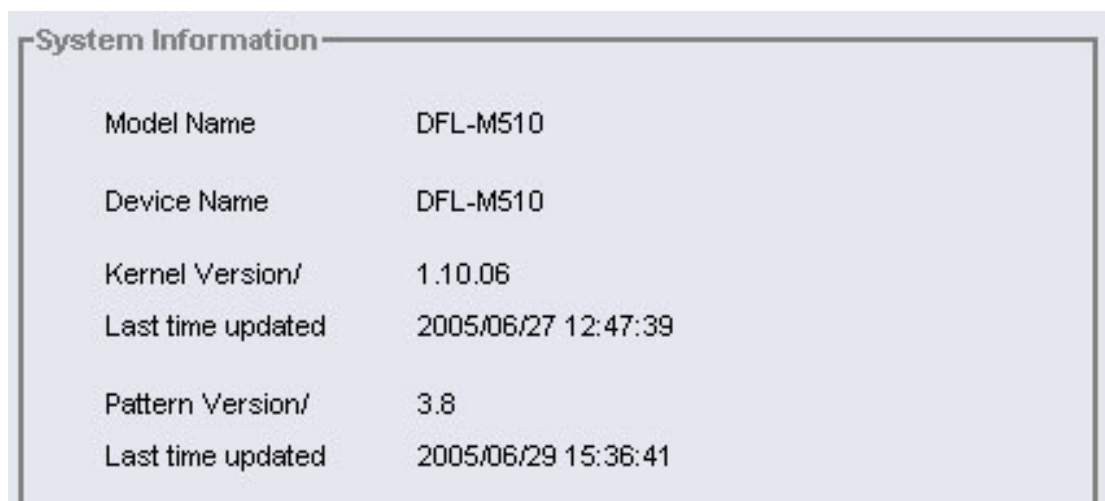
Fig.8

1. SNMP Trap function: When connection link up / down, device can't send the trap.
2. Pattern version display error: The correct version is 3.08, but display is 3.8 in **policy status**. Please see the Fig.8.
