Firmware Version: v 3.10.012
Prom Code Version: v 2.00.003
Published: Jan. 21, 2014

These release notes include important information about D-Link switch firmware revisions. Please verify that these release notes are correct for your switch:

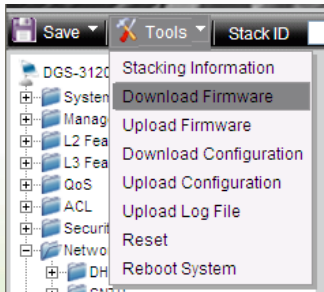
1. Connect a workstation installed with java SE runtime environment to any switch port of the device.
2. Open the web browser from the workstation and enter the IP address of the switch. The switch's default IP address is **10.90.90.90**.
3. Enter administrator's username and password when prompted. It should be noted that the username and password are blank by default.
4. To update switch's firmware or configuration file, select **Tools > Download Firmware** from the banner.

5. Enter the TFTP Server IP address.
6. Enter the name of the firmware file located on the TFTP server.
7. Enter the destination path and the desired file name.
8. Click **Download** button.

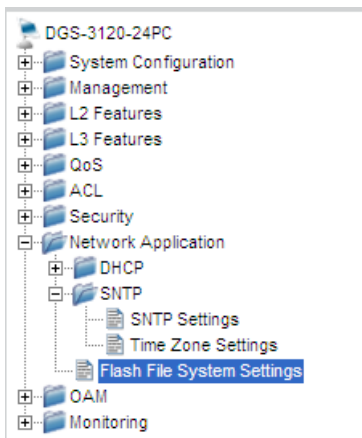
10. To select the boot up image used for next reboot, click **Network Application > Flash File System Settings** in the function tree and then click the **C:** drive name. When you see the files list, click corresponding **Boot Up** button to specify the firmware that will be used for next and subsequent boot up.
