Firmware Version: 4.12.016
Boot Code Version: 1.00.014
MIB Version: 4.12.004
D-View Module Version: 4.0.0.6
Published: Apr. 29, 2016

These release notes include important information about D-Link switch firmware revisions. Please verify that these release notes are correct for your switch:

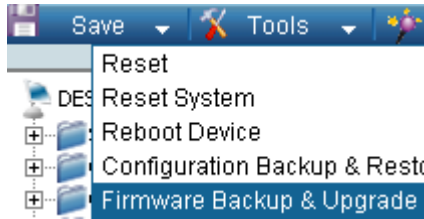
1. Connect a workstation installed with java SE runtime environment to any port of the switch.
2. Open the web browser from the workstation and enter the IP address of the switch. The switch's default IP address is 10.90.90.90.
3. Enter administrator's password when prompted. The password is **admin** by default.
4. To update switch's firmware or configuration file, select **Tools > Firmware Backup & Upgrade** from the banner.

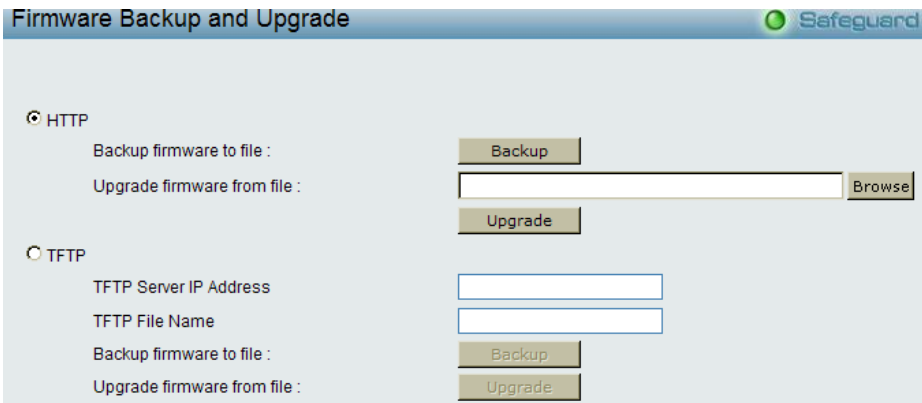
5. Two options : **HTTP** or **TFTP**

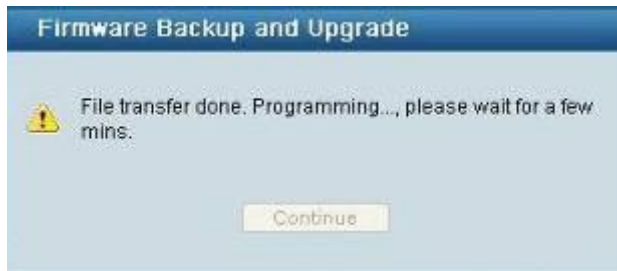
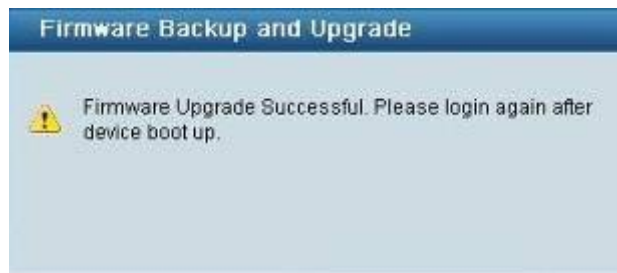
e. Wait until the "Firmware Upgrade Successful" message pops up and login again after device boots up.

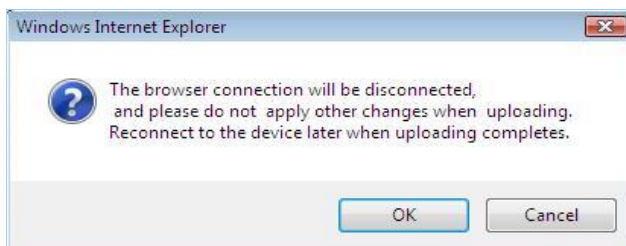
- 7. Select **TFTP** to upgrade the firmware from a remote TFTP server.
 - a. Enter the name of the firmware file located on the TFTP server
 - b. Click **Upgrade** after selecting the firmware file you want to restore
 - c. Click **OK** to continue with firmware upgrade

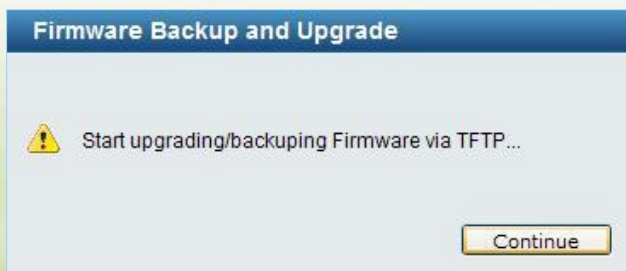
d. Wait until the firmware upgrade ends and login again after device boots up.
