Firmware Version: 6.30.016
Boot Code Version: 1.02.001
MIB Version: 6.30.016
D-View Module Version: N/A
Published: Aug. 23, 2021

These release notes include important information about D-Link switch firmware revisions. Please verify that these release notes are correct for your switch:

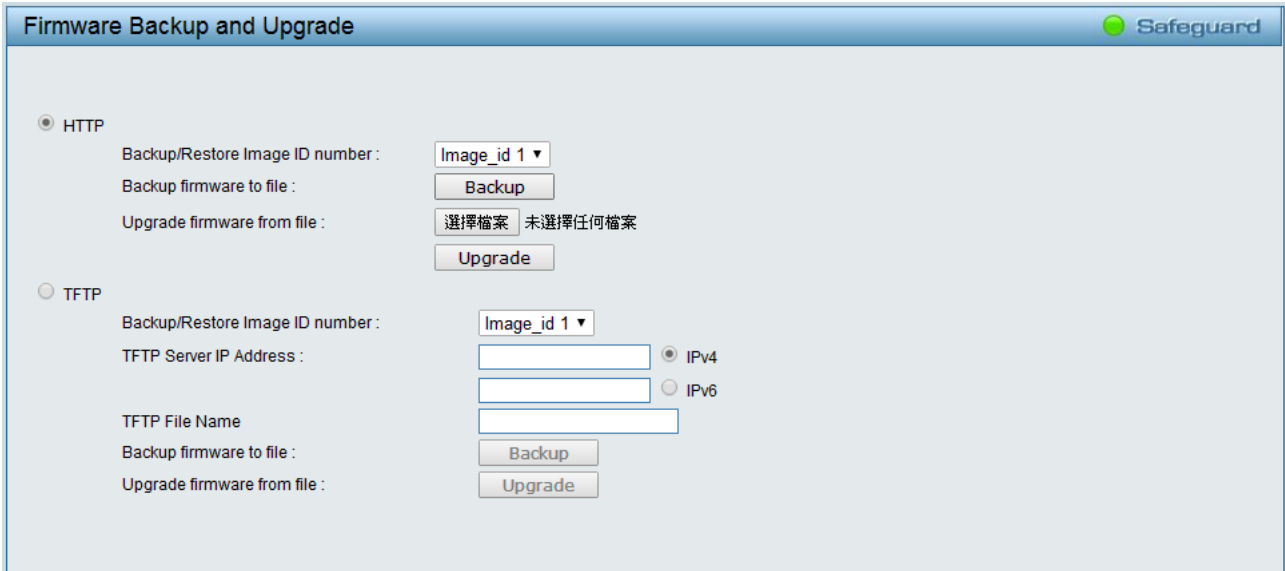
5. Two methods can be selected : **HTTP** or **TFTP**
