**Firmware Version:** 6.12.B001  
**Boot Code Version:** 1.00.010  
**MIB Version:** 6.12.B001  
**D-View Module Version:** N/A  
**Published:** Sep . 06, 2019

These release notes include important information about D-Link switch firmware revisions. Please verify that these release notes are correct for your switch:

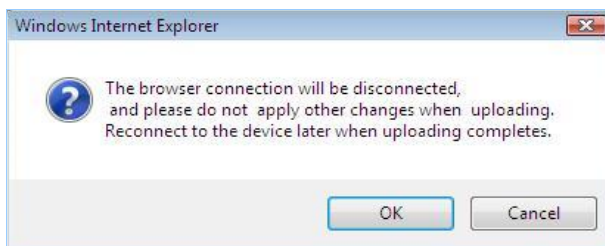
6. Select **HTTP** to upgrade the firmware to or from your local drive of PC.
  - a. Click **Browse** to browse your inventories for a saved firmware file
  - b. Click **Upgrade** after selecting the firmware file you want to restore
  - c. Click **OK** to continue with firmware upgrade

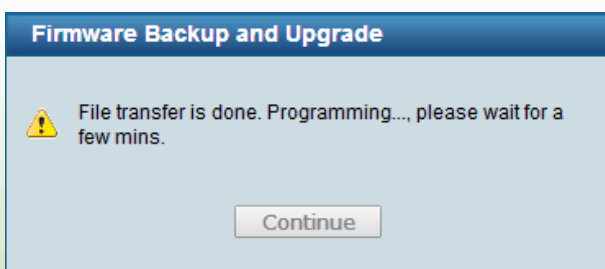
- e. Wait until the "Firmware Upgrade Successful" message pops up and login again after device boots up.

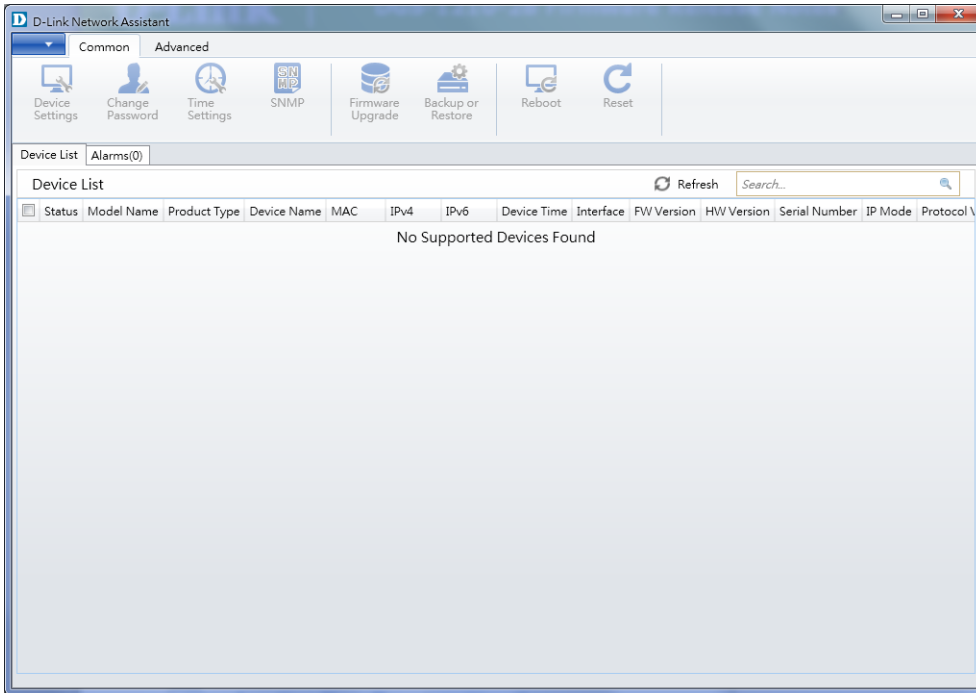
1. Connect a workstation installed with java SE runtime environment to any switch port of the device
2. Execute D-Link Network Assistant
