**Firmware Version:** V1.16.002  
**Prom Code Version:** V1.00.006  
**Published:** Jan. 28, 2021

These release notes include important information about D-Link switch firmware revisions. Please verify that these release notes are correct for your switch:

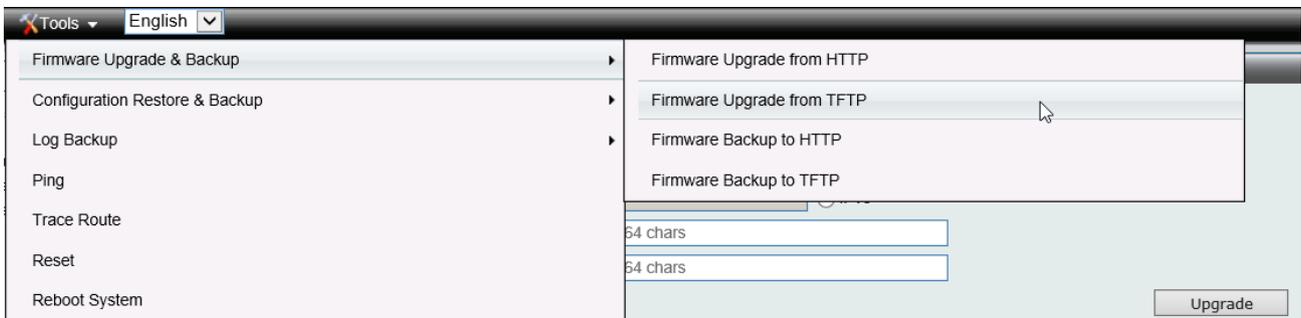
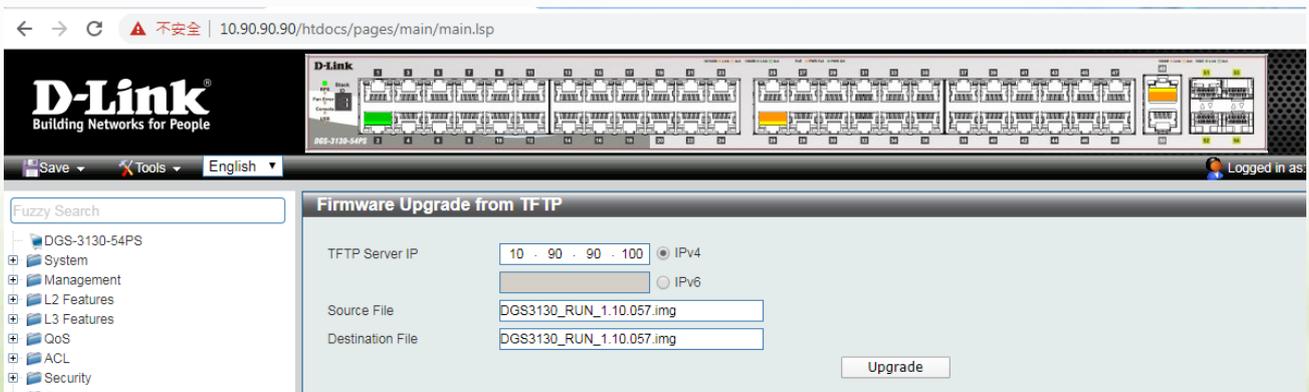
1. Connect a workstation installed with java SE runtime environment to any switch port of the device.
2. Open the web browser from the workstation and enter the IP address of the switch. The switch's default IP address is 10.90.90.90.
3. Enter administrator's username and password when prompted. It should be noted that the username and password are blank by default.
4. To update switch's firmware or configuration file, select **Tools > Firmware Upgrade & Backup** from the banner.

5. Enter the TFTP Server IP address.

6. Enter the location and name of the Source File on the TFTP server (ex. DGS3130\_RUN\_1.10.B032.img) and name of the destination file in the switch.
7. Click "**Upgrade**" button.
8. Wait until the "Current Status" reaches 100% and shows "Done".

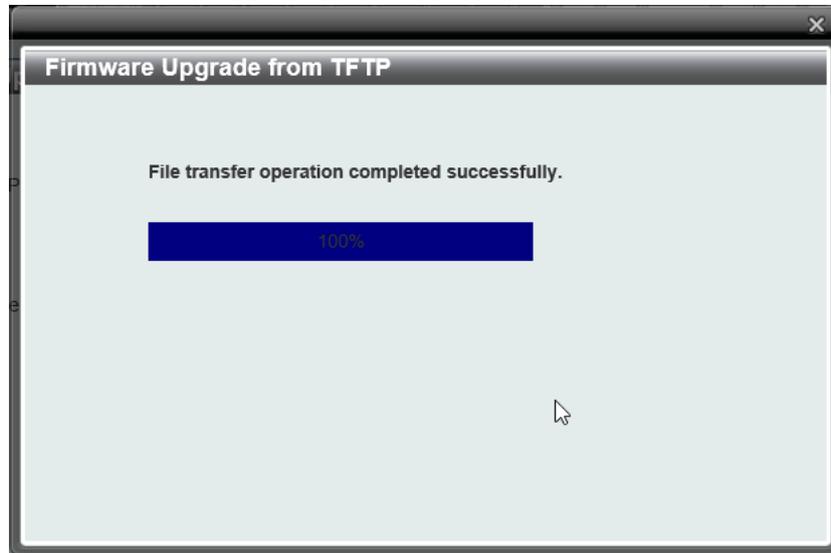
9. To select the boot up image used for next reboot, click "**Management > File System**" in the function tree. Enter the Current Path string and click the Go button or click the C: to enter "File System" window.

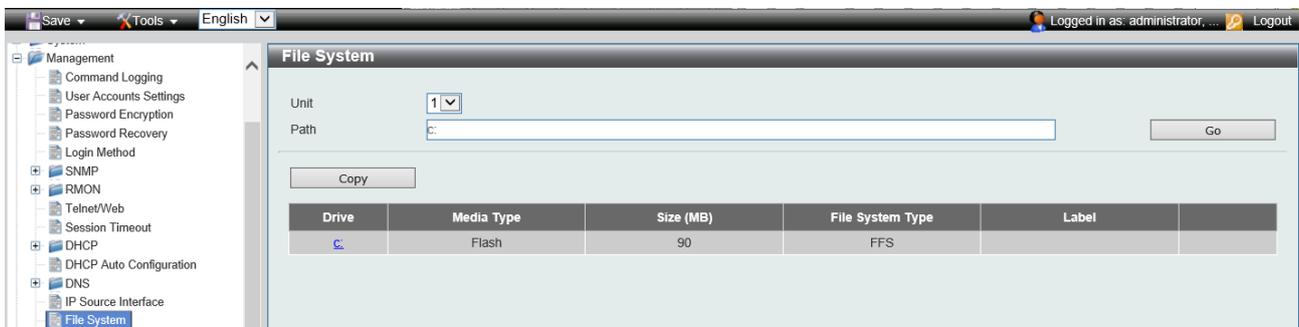
10. Click corresponding "**Boot UP**" button to specify the firmware that will be used for next and subsequent boot up.

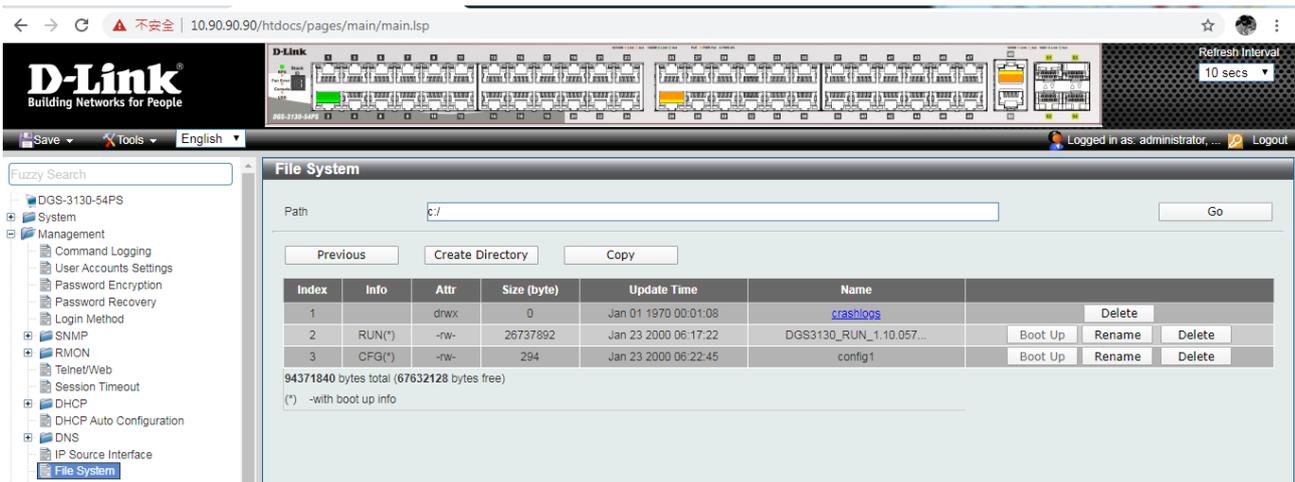
11. To reboot the switch, select **Tools > Reboot System** from the banner.

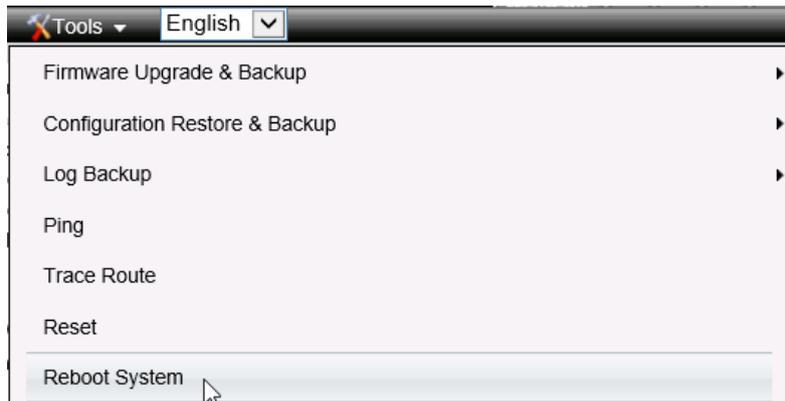
12. Select "Yes" and click "Reboot" button to reboot the switch.
