Firmware Version: 2.25.018
Boot Code Version: 2.25.002
Published: Feb. 24, 2021

The release notes include important information about D-Link switch firmware revisions. Please follow below steps to find version information:

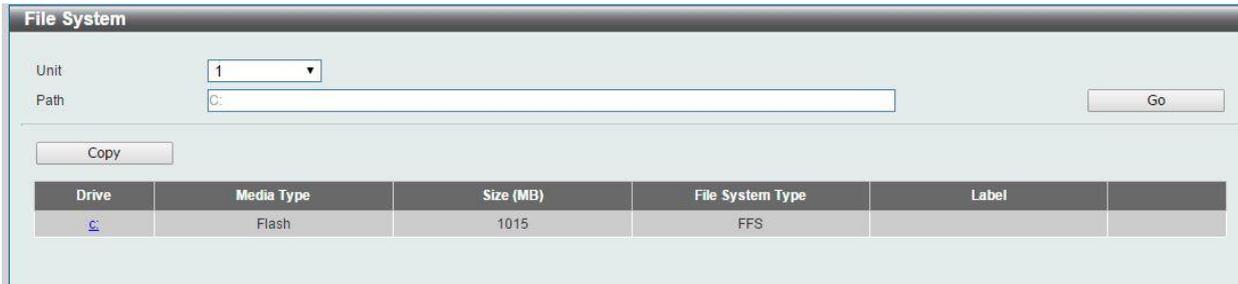
11. Select the boot up image: click **Management > File System** to open the **File System** window

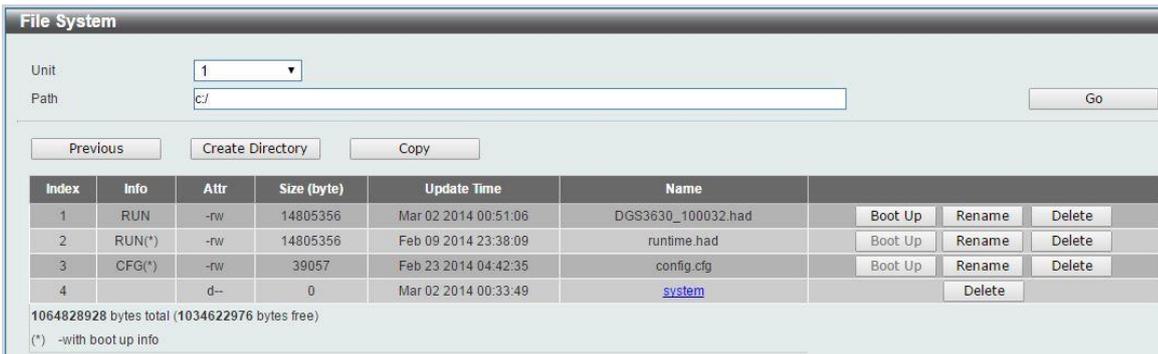
Click [c:](#) hyperlink, the following window will appear.

Click **Boot Up** button to set a specific runtime image as the boot up image

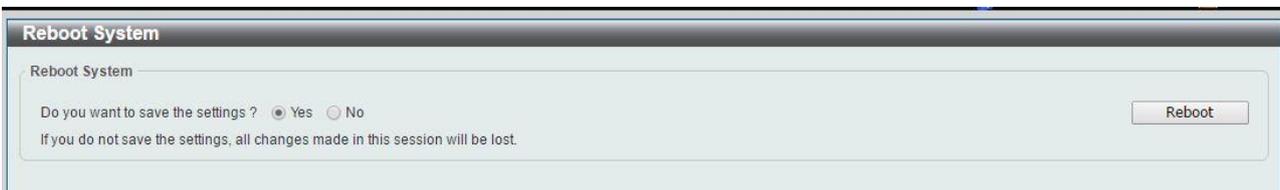
- Reboot the system: click **Tool > Reboot System**, as shown below; click **Reboot** to reboot the switch. When rebooting the switch, any configuration changes that was made during this session, will be lost unless the **Yes** option is selected when asked to save the settings

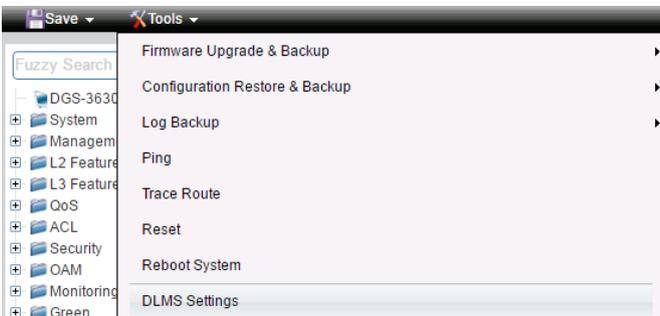
1. Connect a workstation installed with java SE runtime environment to any switch port of the device.
2. Open the web browser from the workstation and enter the IP address of the switch. The switch's default IP address is 10.90.90.90.
3. Enter administrator's password when prompted. There is **no** username and password by default.
4. To update switch's firmware or configuration file, select **Tool > DLMS Settings** from the banner.

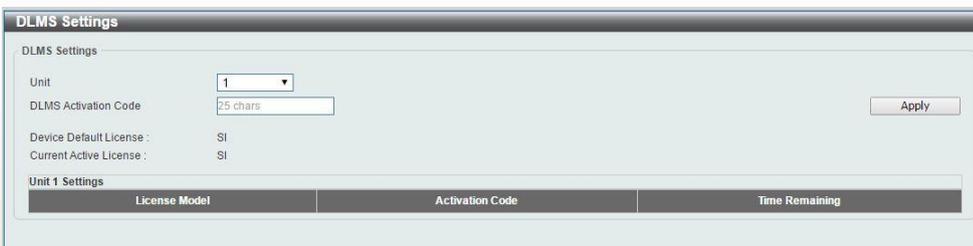
5. Enter the Activation Code and select unit of stack then click **Apply** to activate the assigned switch.

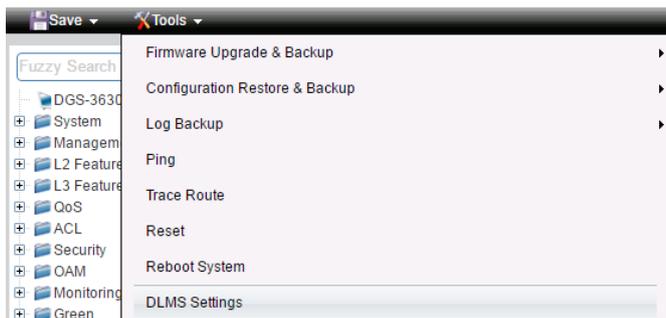
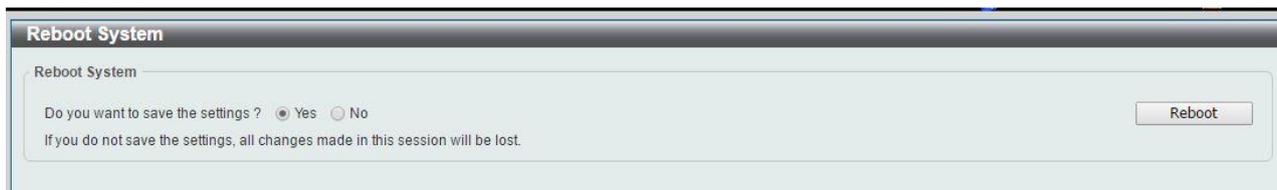
6. To reboot the switch, select **Tools > Reboot System** from the banner.
7. Select **Yes** and click **Reboot** button to reboot the switch.
