**Firmware Version:** 2.11.001  
**Boot Code Version:** 1.01.002  
**MIB Version:** 2.11.001  
**Published:** Mar. 23, 2026.

These release notes include important information about D-Link switch firmware revisions. Please verify that these release notes are correct for your switch:

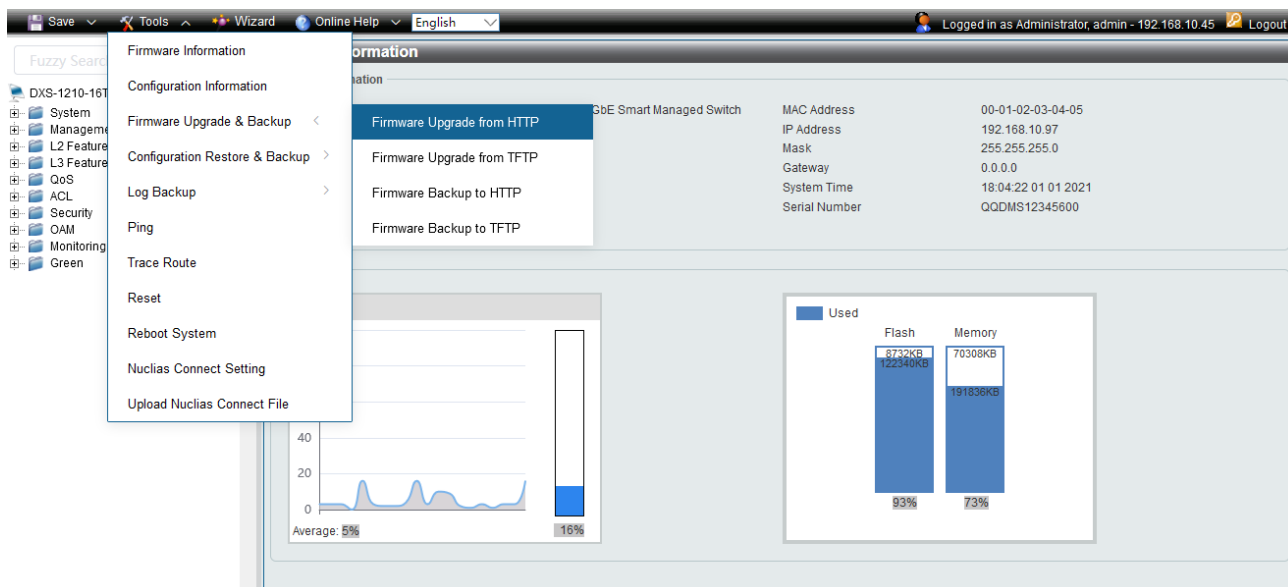
1. Connect a workstation to any switch port of the device.
2. Open the web browser from the workstation and enter the IP address of the switch. The switch's default IP address is 10.90.90.90.
3. Press OK to login. Both the username and password are **"admin"** by default.
4. To update switch's firmware or configuration file, select **Tools > Firmware Backup & Upgrade** from the banner.

5. Two methods can be selected : **HTTP** or **TFTP**
6. Select **Firmware Update from HTTP** to upgrade the firmware to or from your local drive of PC.

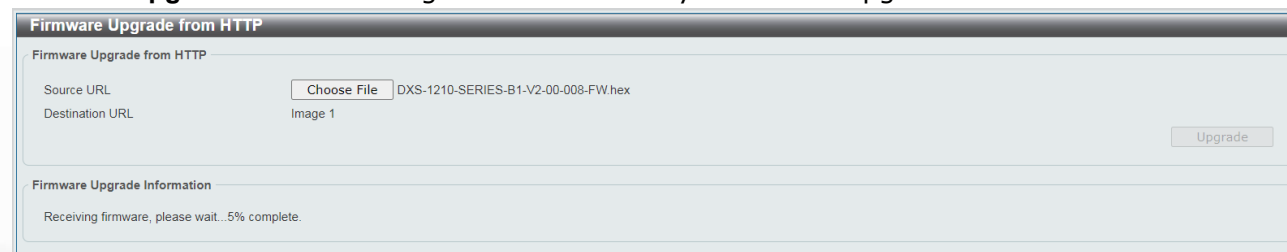
- b. Click **Upgrade** after selecting the firmware file you want to upgrade

- c. It will be download the firmware file to DUT.
- d. When download success, do not power off, and will continue process upgrading (write firmware to flash).

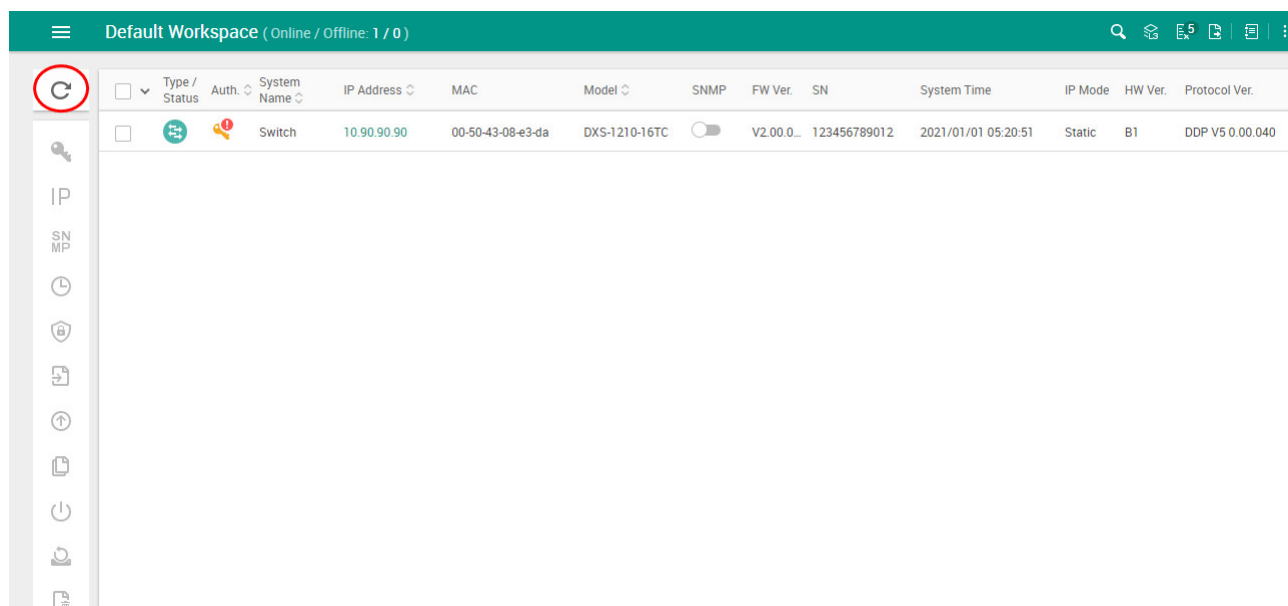
## 3. Click Refresh button to search target switch

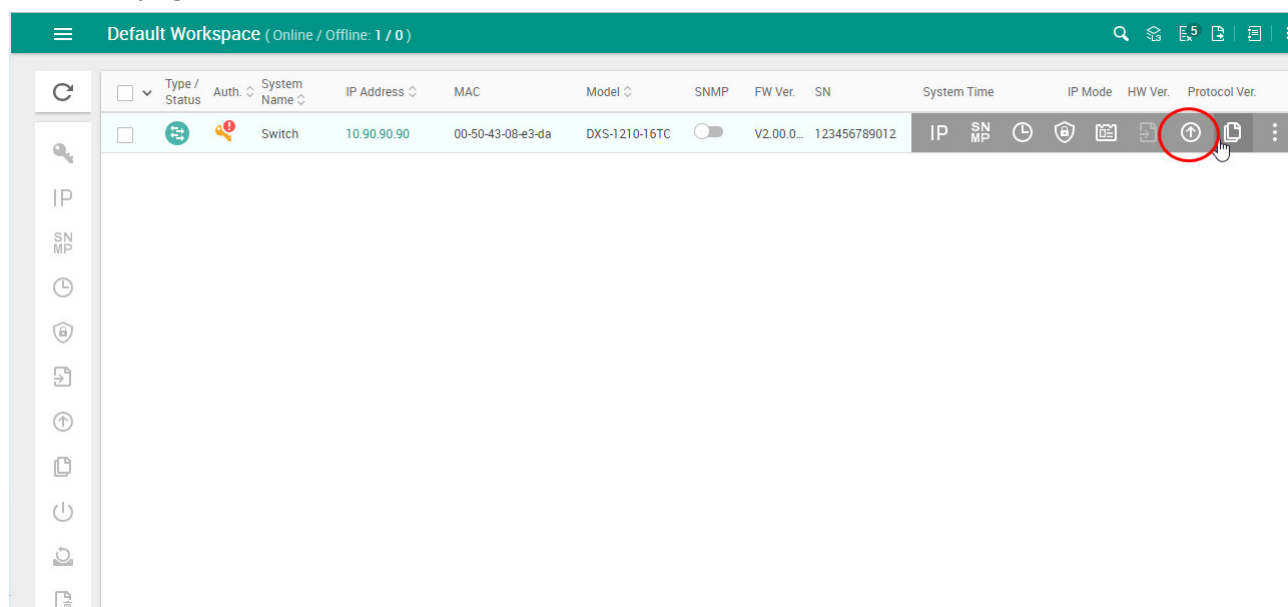
## 4. Move mouse to target device entry, then click "Upgrade firmware" button into upgrade firmware page

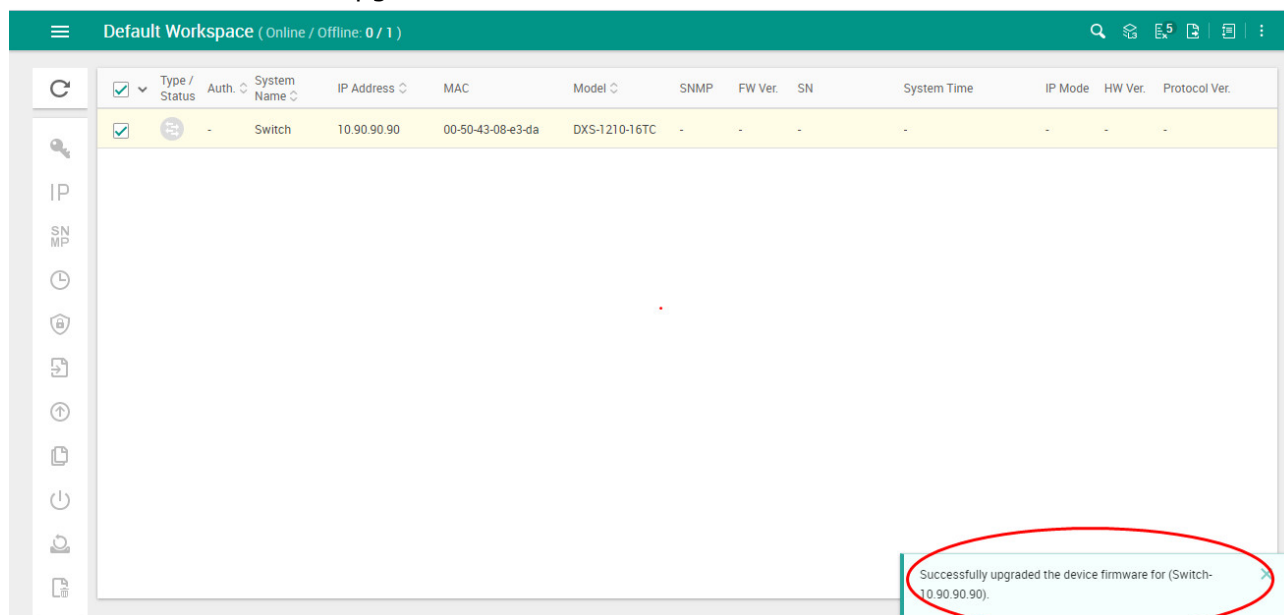
## 8. Wait until firmware upgrade finished.

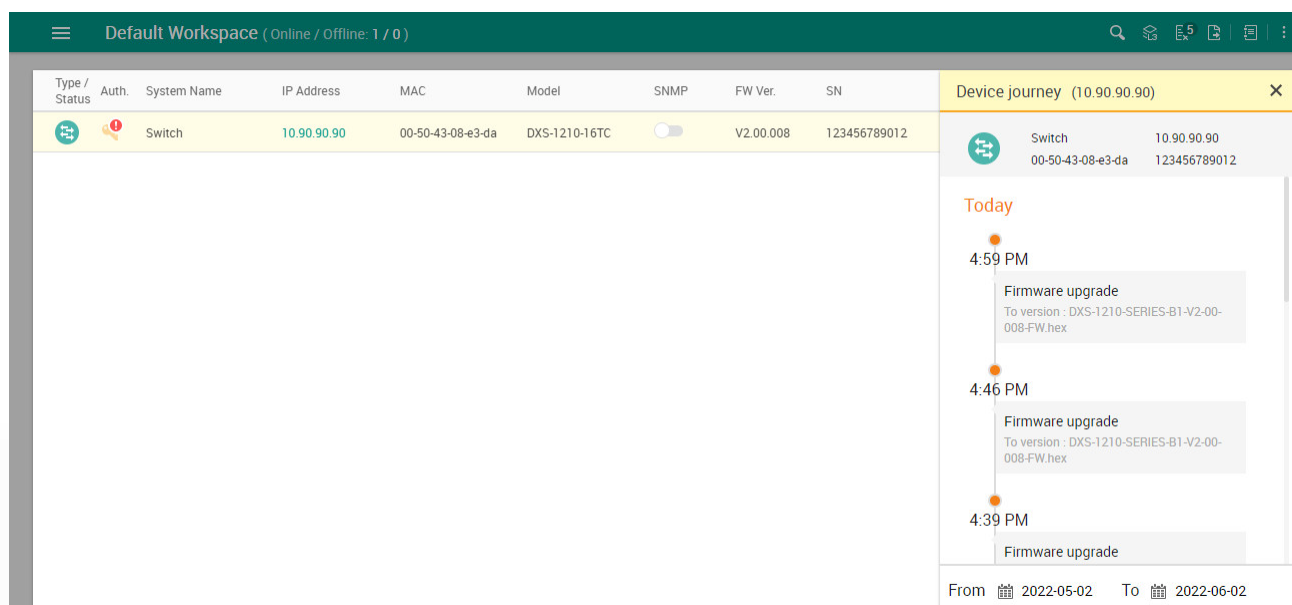
## 9. The DNA pop an information to notify firmware upgrade status. Also can get firmware upgrade status from "Device journey" page.
