Firmware Version: V4.00.024
Prom Code Version: V4.00.002
Published: Jan 13, 2011

These release notes include important information about D-Link switch firmware revisions. Please verify that these release notes are correct for your switch:

For DES-3200 series C1 (DES-3200-26/28/28P/52/52P C1, FW: R4.00.020 or above)

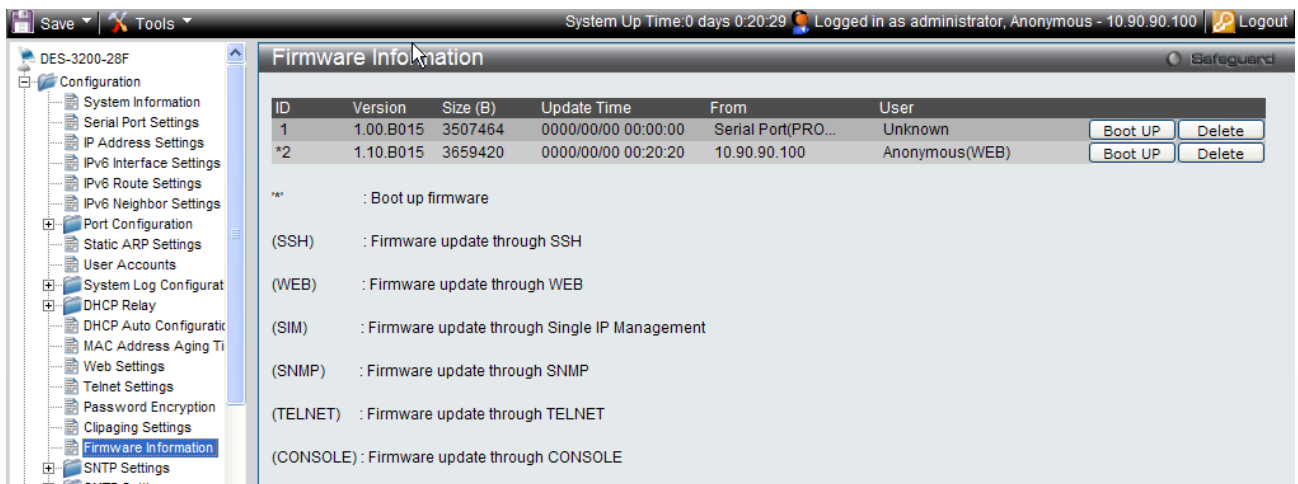
11. To reboot the switch, select **Tools > Reboot System** from the banner.
12. Select "**Yes**" and click "**Reboot**" button to reboot the switch.
