Firmware Version: 6.32.008
Boot Code Version: 1.02.001
MIB Version: 6.31.002
D-View Module Version: N/A
Published: Dec.07, 2023

These release notes include important information about D-Link switch firmware revisions. Please verify that these release notes are correct for your switch:

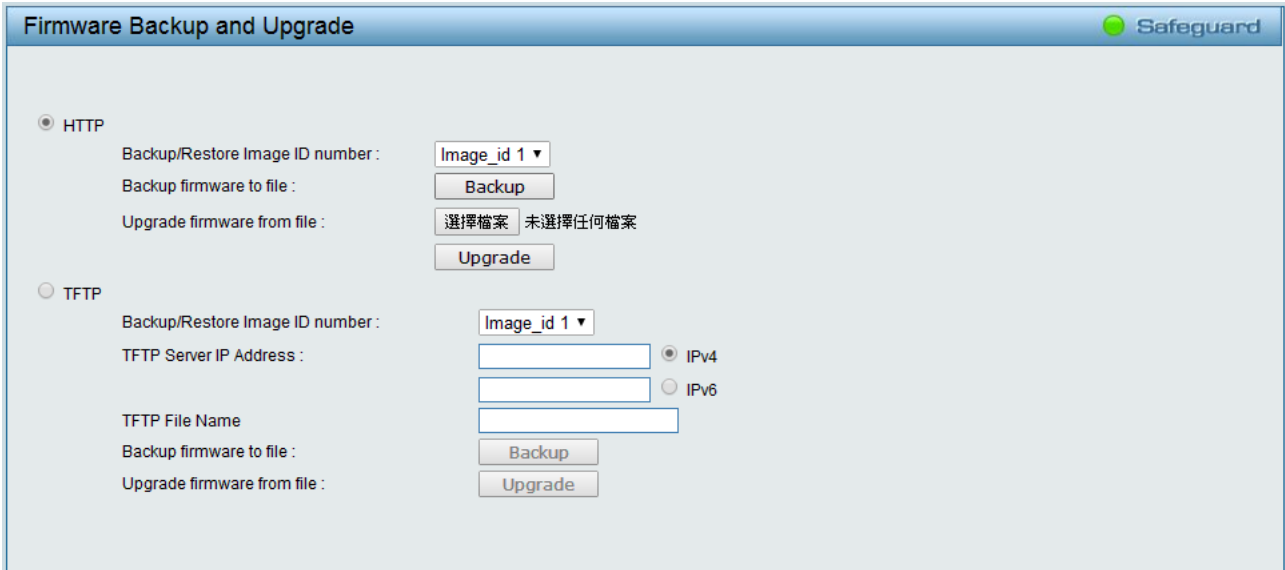
5. Two methods can be selected : **HTTP** or **TFTP**

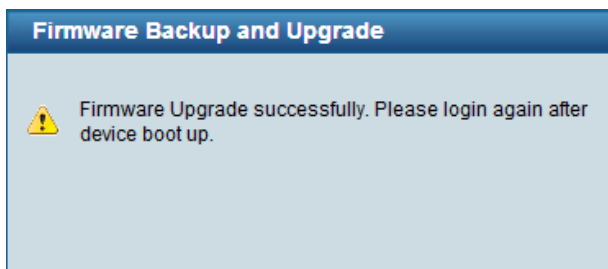
- e. Wait until the "Firmware Upgrade Successful" message pops up and login again after device boots up.

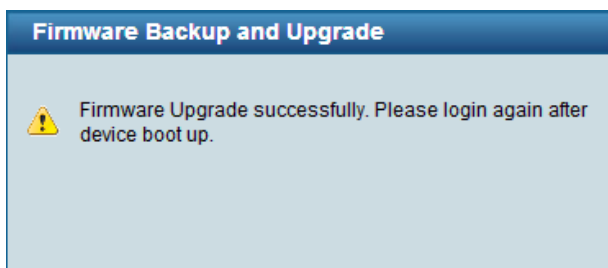
- d. Wait until the firmware upgrade ends and login again after device boots up.

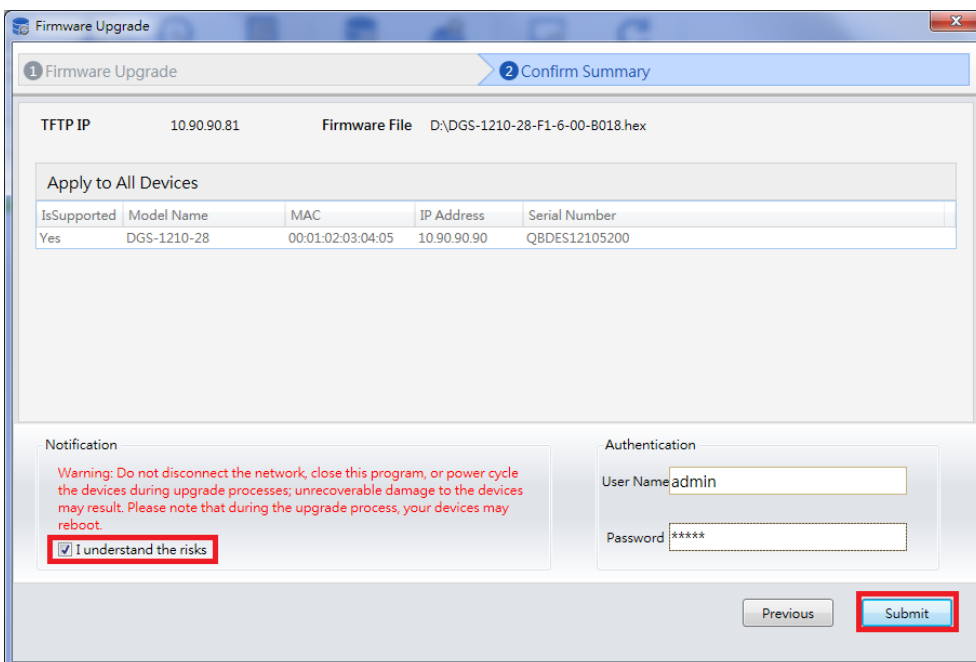
7. Click the checkbox and click "Submit" button to start firmware upgrade.
