Firmware Version: V2.00.021
Prom Code Version: V1.00.011
Published: Mar. 14, 2023

These release notes include important information about D-Link switch firmware revisions. Please verify that these release notes are correct for your switch:

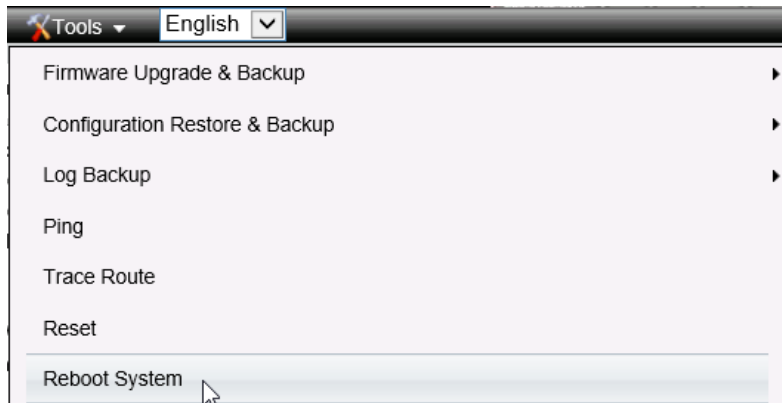
11. To reboot the switch, select **Tools > Reboot System** from the banner.

12. Select "Yes" and click "Reboot" button to reboot the switch.
