Firmware Version: 4.7.6.1 B
101_WW/RU

Revision History and System Requirement:

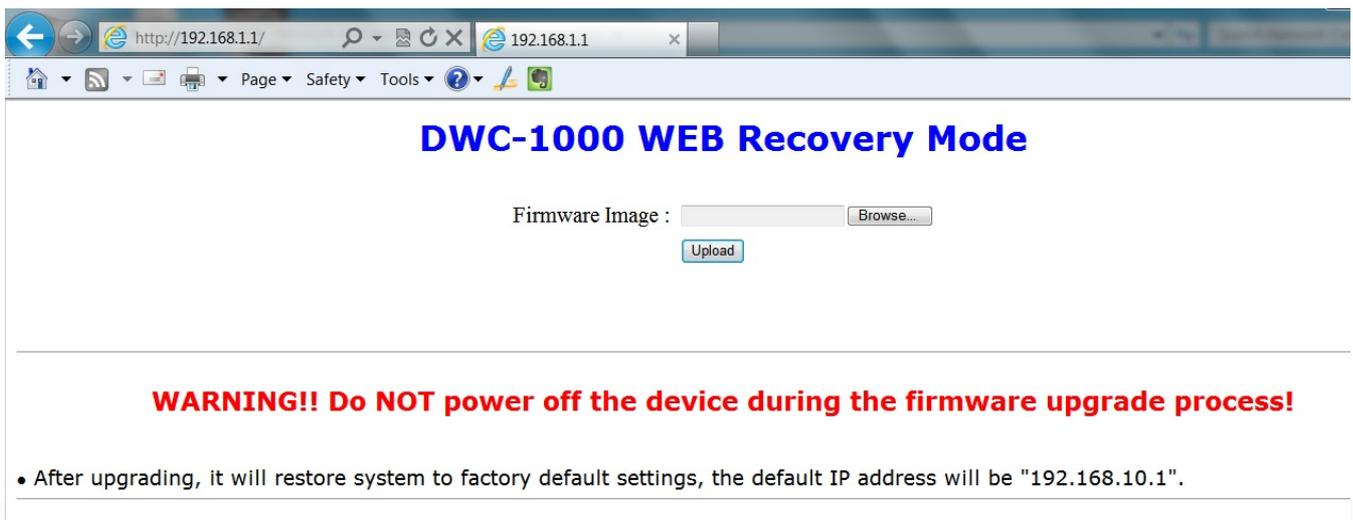
The IP address will be 192.168.1.1, and make sure to setup same IP segment for your PC/NB then access the Web Recovery Mode via browser.

3. B1 firmware is not backward compatible with HW A1, please make sure the hardware version is correct before upgrading firmware for DWC-1000.
4. Hardware B1 supports **Web Recovery Mode** whenever there is firmware damage on DWC-1000, or manually access it by following steps: Power off the DWC-1000, press and hold the reset button, then power on and keep hold the reset button for over 15 seconds, the DWC-1000 will enter the Web Recovery Mode either.
