**Firmware Version:** V3.00.004  
**Prom Code Version:** V1.00.016  
**Published:** 2017/10/11

These release notes include important information about D-Link DGS-3620 series firmware revisions. Please verify that these release notes are correct for your switch:

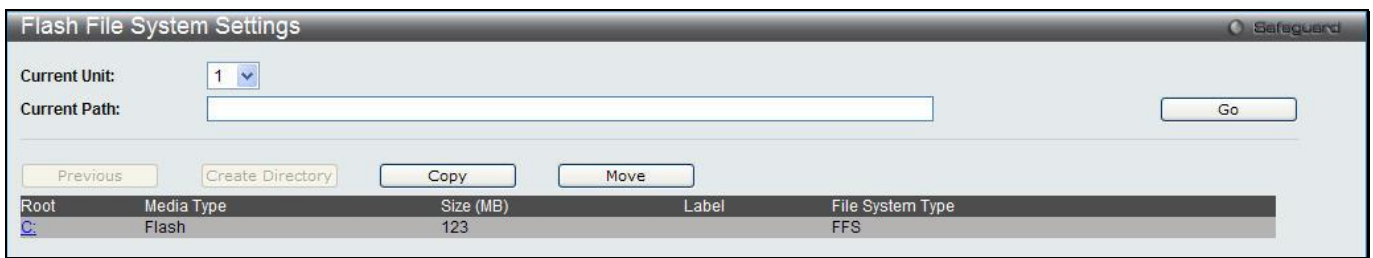
11. To select the boot up image used for next reboot, click **Network Application > Flash File System Settings** in the function tree and then click the **C:** drive name. When you see the files list, click corresponding "**Boot Up**" button to specify the firmware that will be used for next and subsequent boot up.
