**Firmware Version:** 2.01.010  
**Boot Code Version:** 1.00.003  
**MIB Version:** 2.01.010  
**Published:** July. 10, 2023

These release notes include important information about D-Link switch firmware revisions. Please verify that these release notes are correct for your switch:

## Revision History and System Requirement:

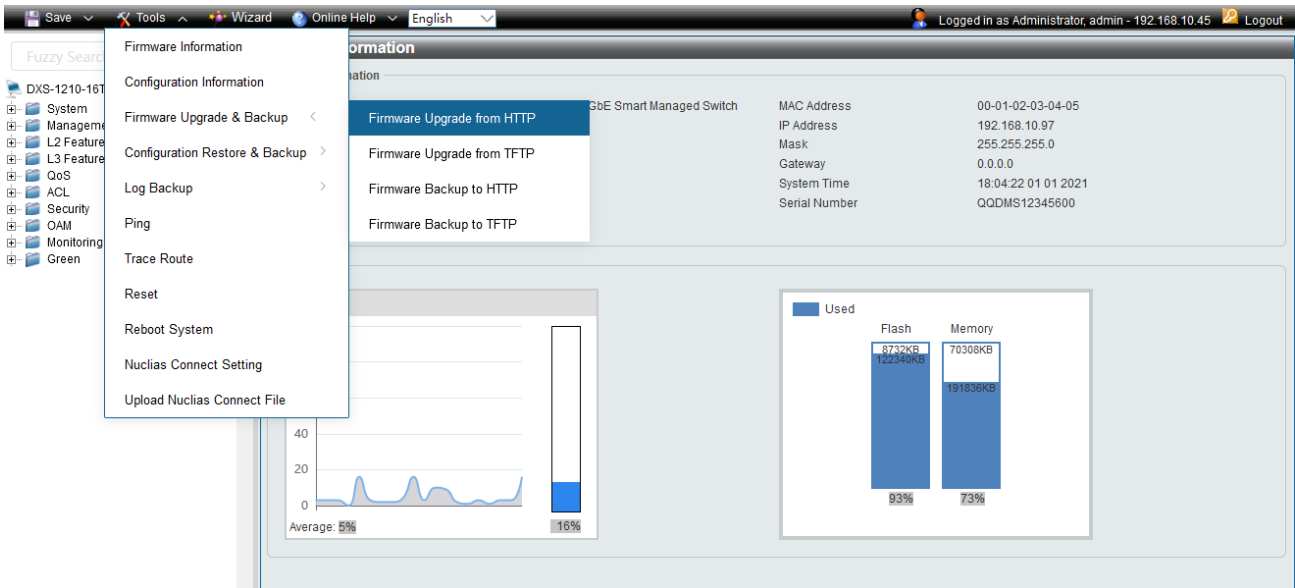
1. Connect a workstation to any switch port of the device.
2. Open the web browser from the workstation and enter the IP address of the switch. The switch's default IP address is 10.90.90.90.
3. Press OK to login. Both the username and password are **"admin"** by default.
4. To update switch's firmware or configuration file, select **Tools > Firmware Backup & Upgrade** from the banner.

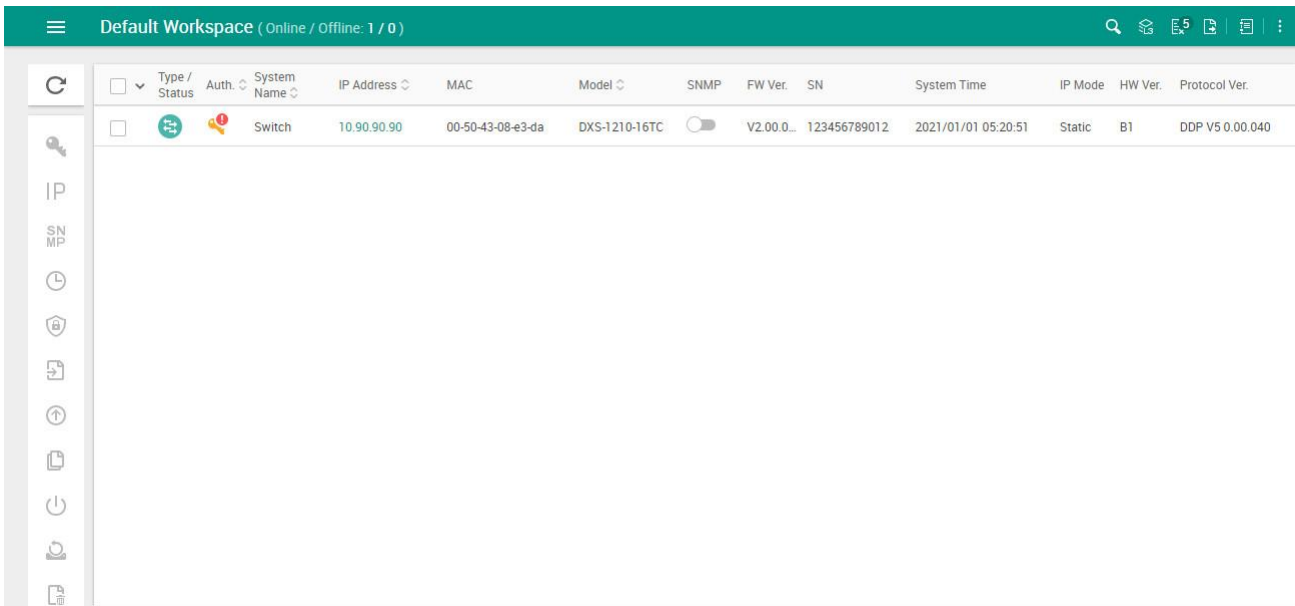
1. Connect a workstation installed with java SE runtime environment to any switch port of the device. Install DNA App in Web Store of Chrome Browser.
2. Execute D-Link Network Assistant App.

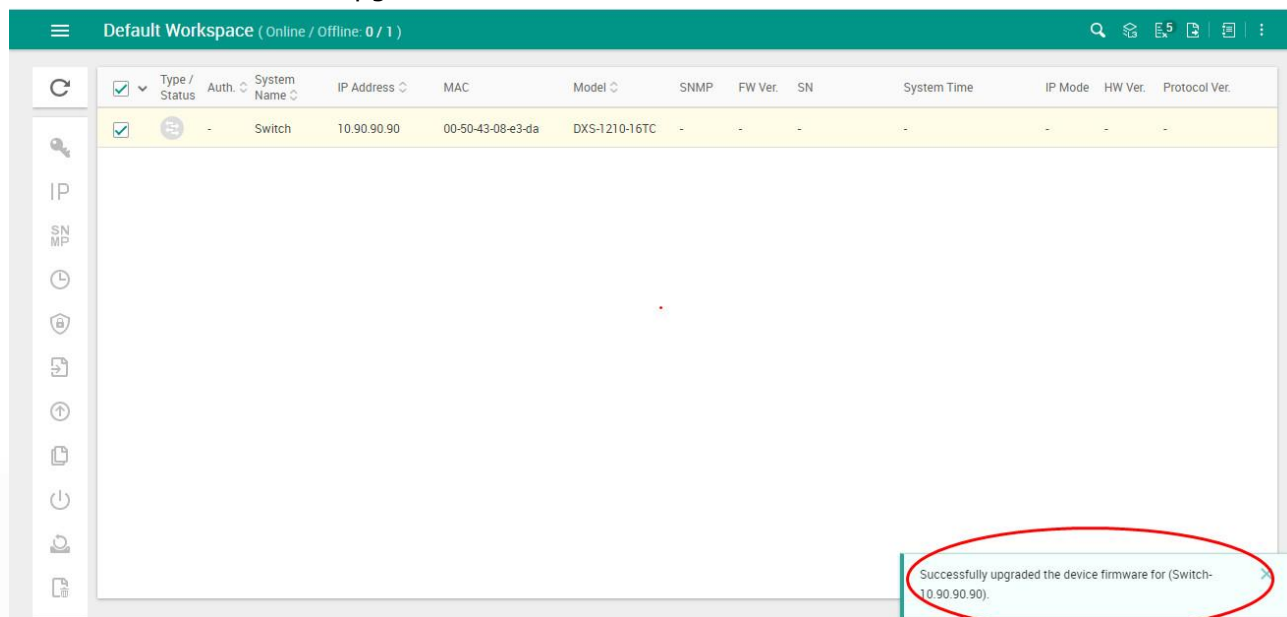
7. Wait until firmware upgrade finished.

8. The DNA pop an information to notify firmware upgrade status. Also can get firmware upgrade status from "Device journey" page.

The screenshot shows the DNA interface with a table of devices and a 'Device journey' pop-up for a switch. The table has columns for Type/Status, Auth., System Name, IP Address, MAC, Model, SNMP, FW Ver., and SN. The 'Device journey' pop-up shows a timeline of events for the switch, including three firmware upgrade events on 'Today' at 4:39 PM, 4:46 PM, and 4:59 PM, all upgrading to version DXS-1210-SERIES-B1-V2-00-008-FW.hex.
