Firmware Version: 2.00.008
Boot Code Version: 1.00.002
MIB Version: 2.00.008
Published: May. 23, 2022

These release notes include important information about D-Link switch firmware revisions. Please verify that these release notes are correct for your switch:

Revision History and System Requirement:

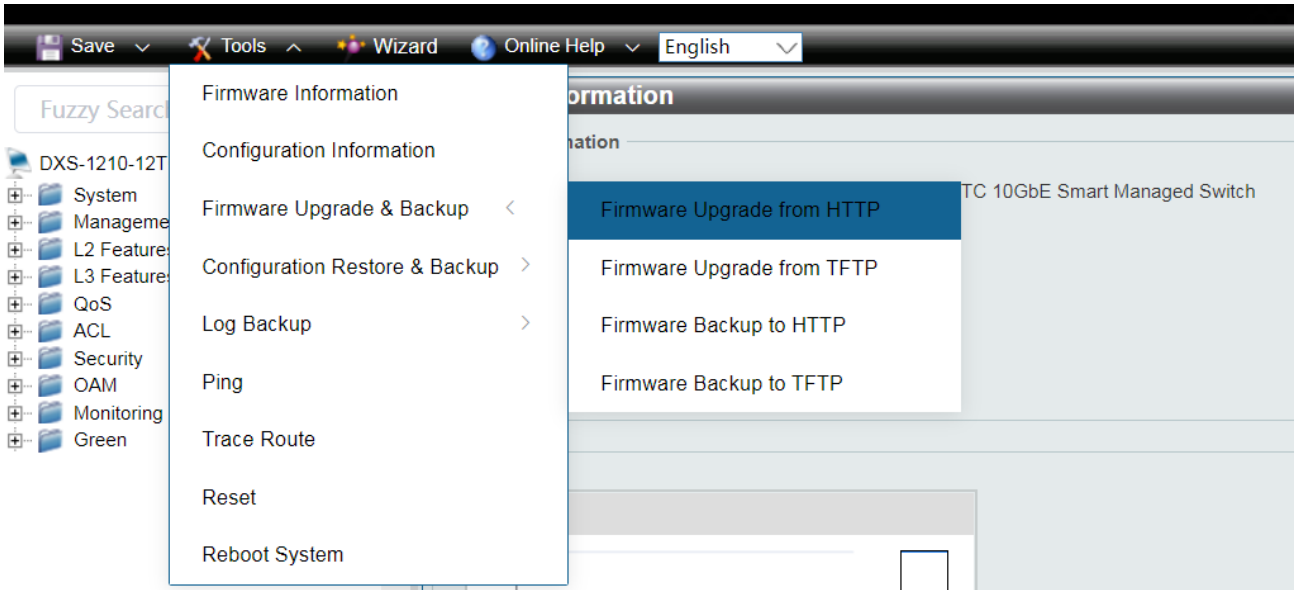
1. Connect a workstation to any switch port of the device.
2. Open the web browser from the workstation and enter the IP address of the switch. The switch's default IP address is 10.90.90.90.
3. Press OK to login. Both the username and password are **"admin"** by default.
4. To update switch's firmware or configuration file, select **Tools > Firmware Backup & Upgrade** from the banner.

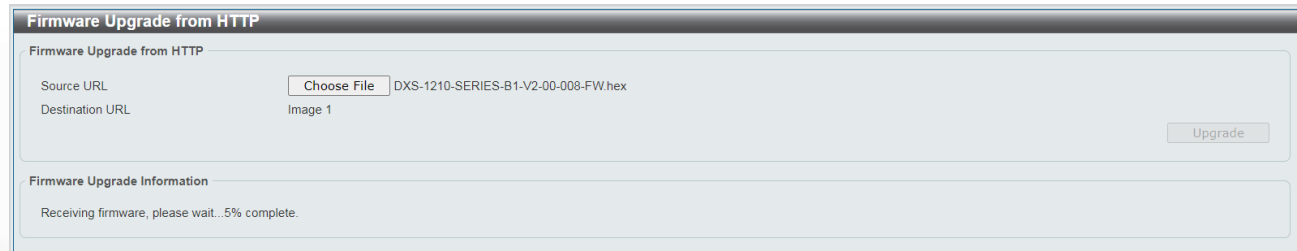
- b. Click **Upgrade** after selecting the firmware file you want to upgrade

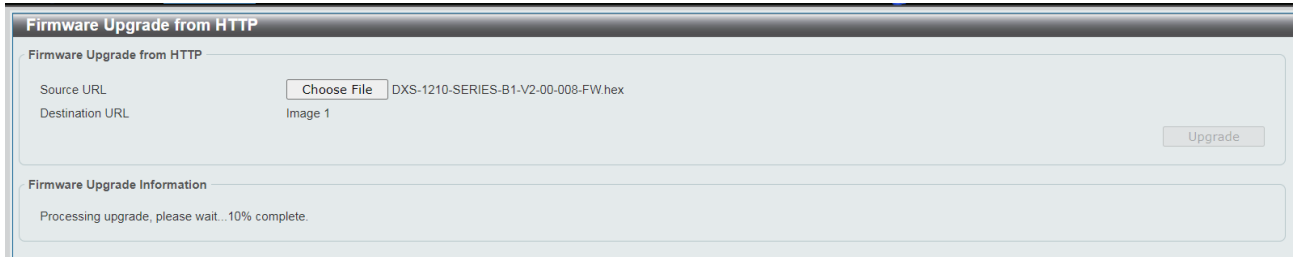
- c. It will be downloading the firmware file to DUT.
- d. When download success, do not power off, and will continue process upgrading (write firmware to flash).

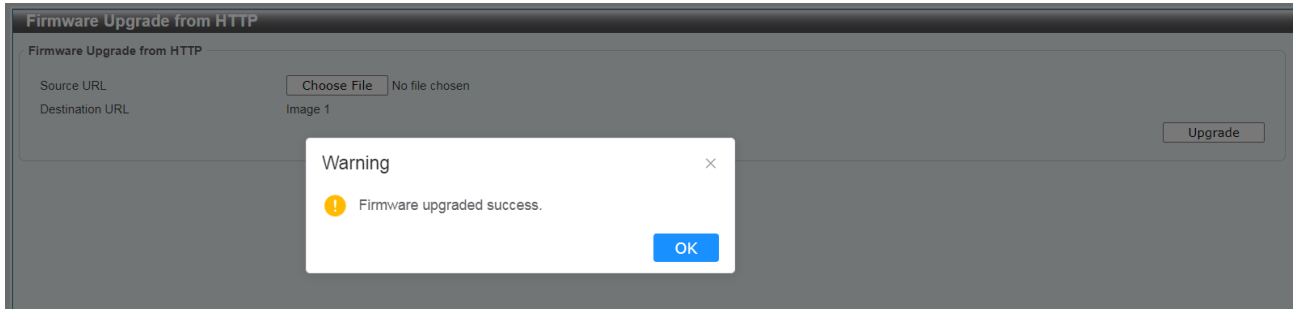
e. Wait until the "Firmware Upgrade Successful" message pops up.

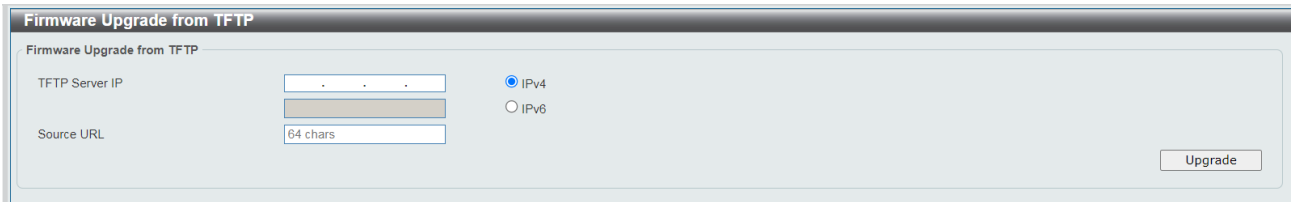
7. Select **TFTP** to upgrade the firmware to or from a remote TFTP server.

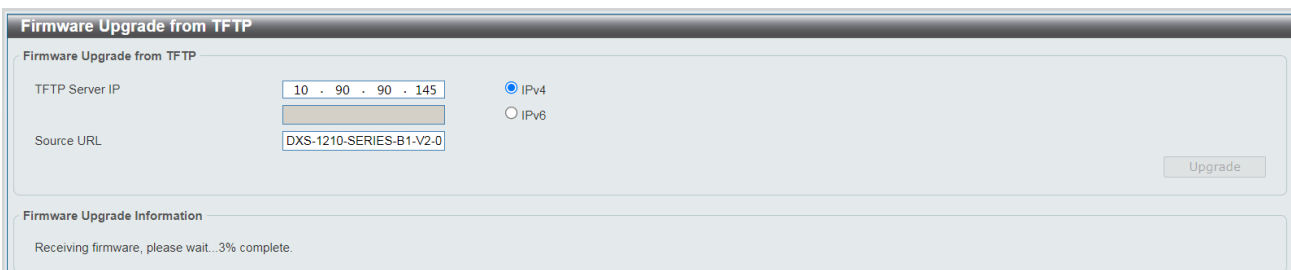
- a. Enter the TFTP server IP and the URL of the firmware file located on the TFTP server.
- b. Click **Upgrade** after selecting the firmware file you want to restore.
- c. It will be download the firmware file to DUT.

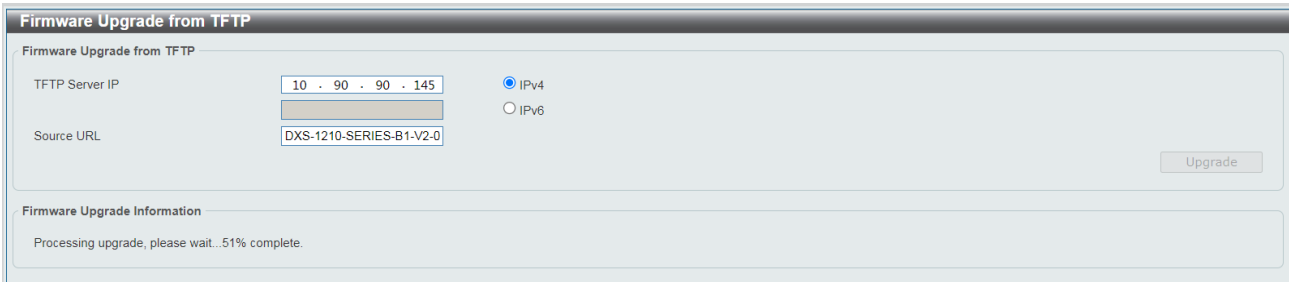
d. When download success, do not power off, and will continue process upgrading (write firmware to flash).

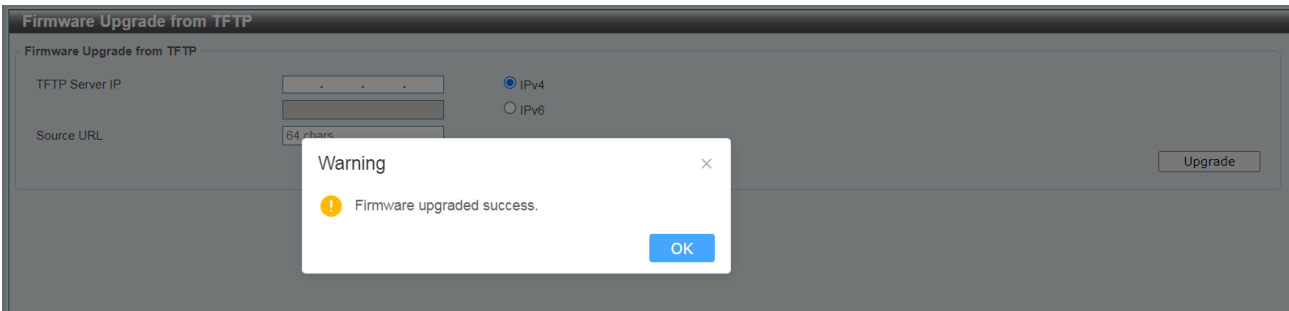
e. Wait until the firmware upgrade ends.
